7 December 2021  
Ref: 170108-ER\_DPIE-November 2021

**RE: Sydney Metro City & South West – ER Monthly Reports for November 2021**

Jo Robertson  
Environmental Representative

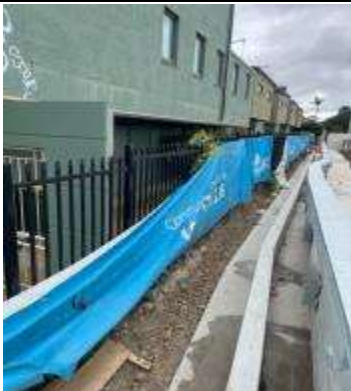
<p><b>Bedwin Road: Shade cloth had come away from some sections of the boundary fence with Edgeware Road apartments</b></p>

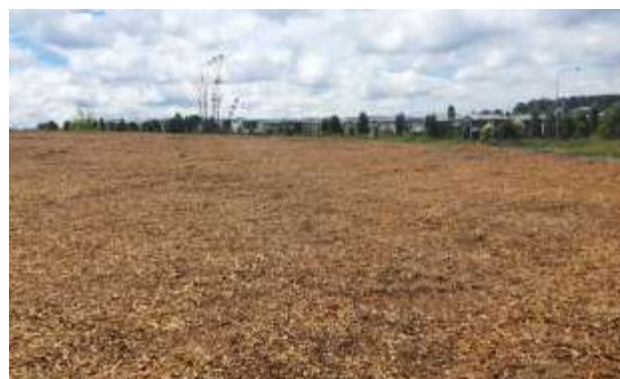
- It was noted that post recent rainfall, minor sections require re-work/re-application of mulch to ensure cover. SC informed the ER that these works would be undertaken once ground conditions (currently wet from recent rainfall) allow machinery to be deployed to complete remaining stabilising works.

**SMTF North – Snake Mountain Ara -Stabilising works are nearing completion with some mulch remaining to be applied and additional ballast to be laid in areas of concentrated flow**

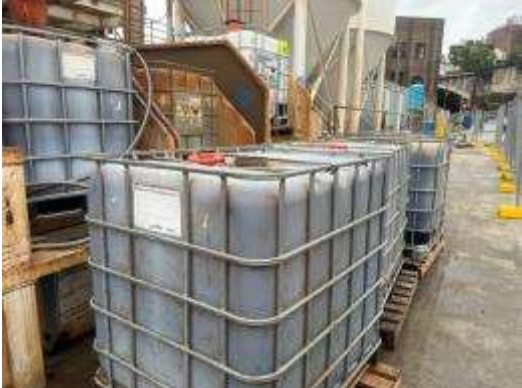
<b>IBCs of Potassium Permanganate stored without secondary containment</b>	<b>Builders sand had been used as a bund to prevent water ingress into open penetrations</b>
<b>Endorsed Document/s</b>	
<ul style="list-style-type: none"> <li>BN OOHWA-005 - Ausgrid Pit Inspection</li> <li>BN OOHWA-002.1 - Station Works, Dec 2021 &amp; Jan 2022</li> </ul>	
<b>Non-compliance/ Incidents or Repeat Complaints</b>	
<p>Sydney Metro has been providing summaries of complaints to DPIE daily and a summary to the ER. Responses to each complaint have been noted in each complaint report, with follow-up actions often defined in revised reports. Key or repeat items of note are discussed below for Barangaroo Station.</p>	
<p>There were no non-compliances reported to the ER for Barangaroo Station for the period.</p>	
<p>There were no incidents for Barangaroo Station reported to the ER under conditions A41 of SSI 7400.</p>

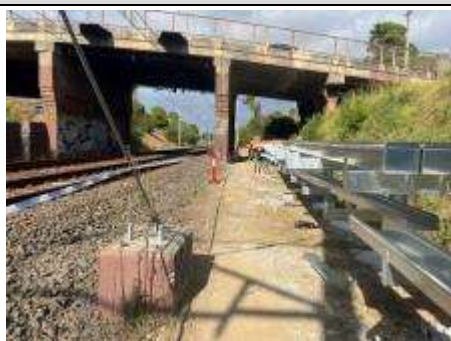
**Moreton Street, Punchbowl:** Cess drainage pits were unprotected in the vicinity of the GST installation work area

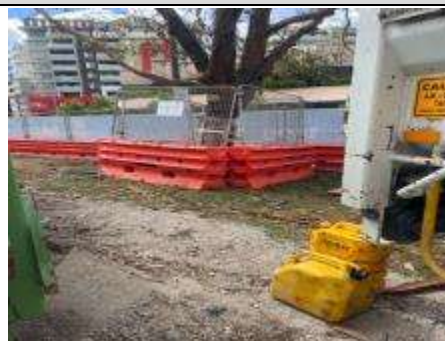
**Bankstown MSB Site:** Two jerry cans of diesel were stored without secondary containment

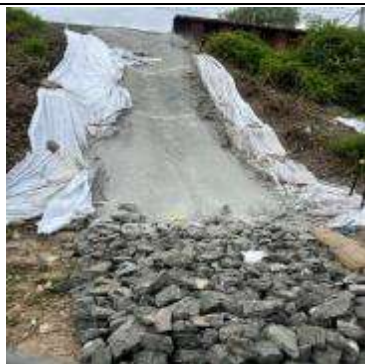
**RW21, Lakemba:** RFI issued for final batter chute design, and plans for removal or respreads of covered material

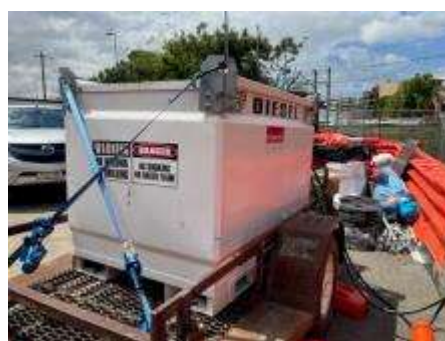
- A generator and 1,000L diesel fuel cell were located adjacent to an open stormwater culvert at the BEW North Terrace Site Compound. While the generator and fuel cell are likely to be self-bunded, there was a risk of fuel leakage or spill via the transfer process. A nearby spill kit bin was almost empty.

**BEW North Terrace Compound:** A generator and 1,000L diesel fuel cell were located adjacent to an open stormwater culvert. Controls have since been placed to reduce risk until the site compound is switched to mains power.
