Metro
Body of
Knowledge

Planning Approval Environmental Review Form

Assessment Name:	High Street Steps rectification
Prepared by:	Sydney Metro
Prepared for:	Sydney Metro and Besix Watpac – Barangaroo Station contractor
Assessment number	TfNSW 76
Type of assessment:	Assessment under EP&A Act 1979, Division 5.2
Version:	Final 2.0
Planning approval No. (where relevant):	SSI_7400
Date required:	7 September 2023
iCentral number	SM-23-00854648

SUBJECT: Advice for repairs to High St Steps landing, Hickson Road Retaining Wall and cutting, Barangaroo

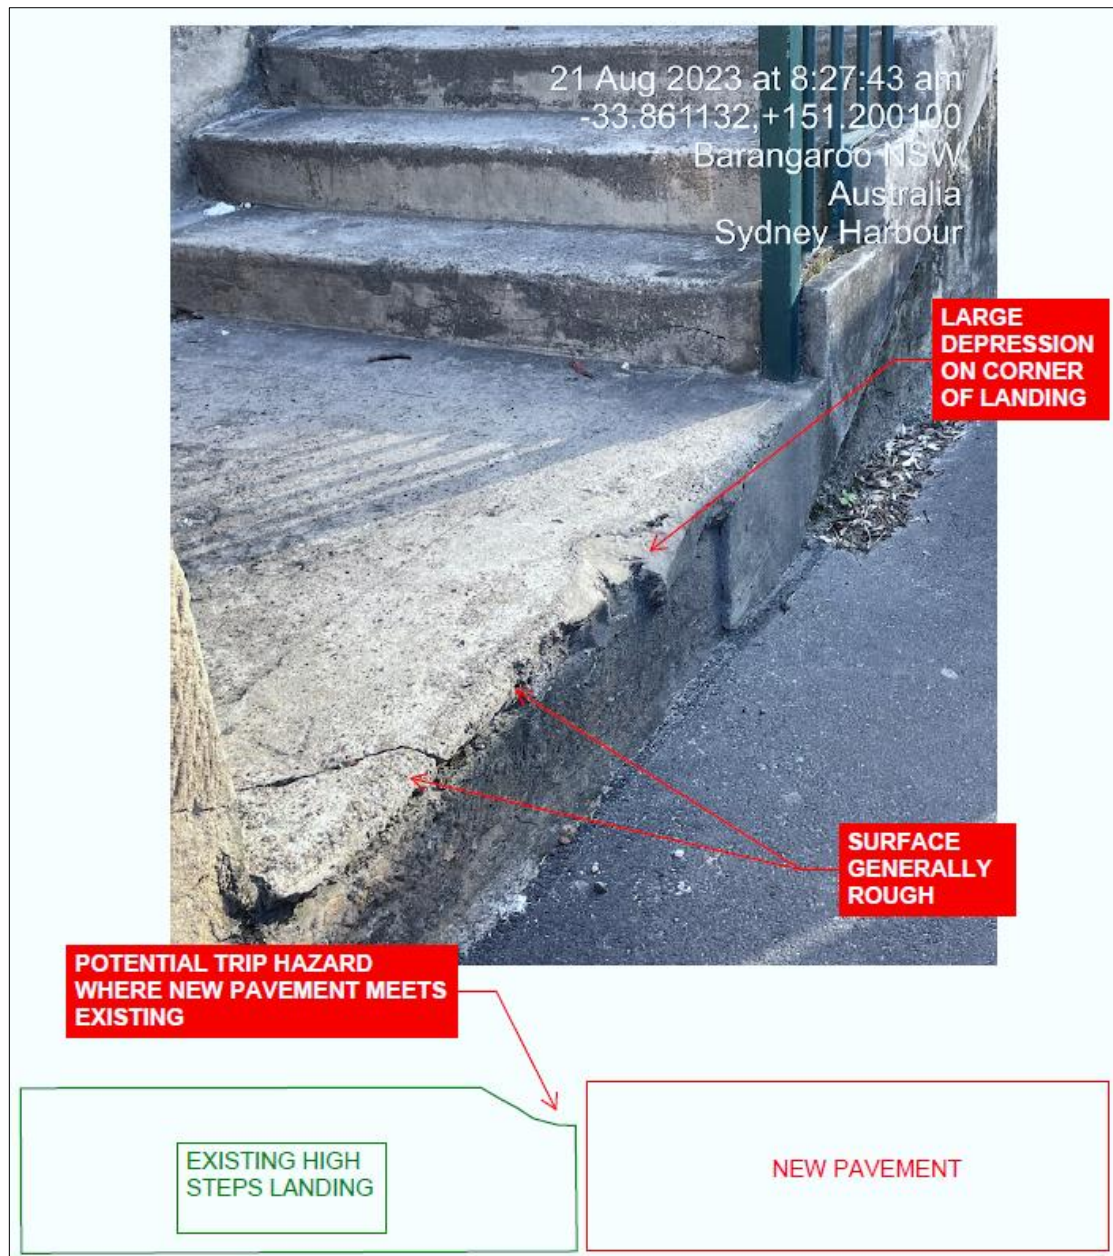
The landing of the High Street steps is in need of repair. The cement render surface is cracked, has rough edges, and old repairs are failing, causing an uneven edge. Reinstatement of the Hickson Road footpath by the project requires the new footpath surface to be flush with the High Street steps landing. The uneven edge will be a trips and falls risk once the footpath is reinstated. Repairs are proposed to the landing surface to eliminate those risks (Figure 1).

Figure 1: Illustration showing the uneven edge and trip hazard once the Hickson Road footpath is reinstated.

Damage to the original sandstone cut should be avoided. Surface repairs should be limited to the removal and replacement of the areas of damaged concrete and underlying cement mortar, and the intrusive repairs only.

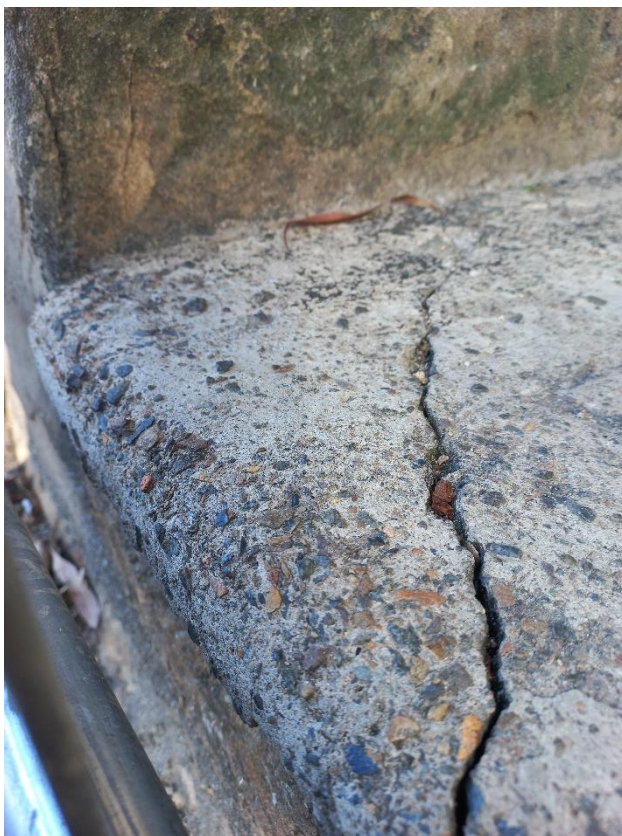
The landing recess has been cut from the outcropping sandstone which forms the lower part of the wall and cutting in this area. The area of the landing has been cut 80-85mm lower than the existing surface and then finished with concrete. There appears to be a layer of fine and brittle cement mortar (c.40mm) between the sandstone and the concrete. This was only visible where the lip of the landing had broken away (Figure 3). The concrete finish contains a dense gravel aggregate (Figure 2). The steps and landing are all finished with the same mix, although there are twentieth-century repairs throughout that have not been matched correctly. The Hickson Road face of the landing step was originally cement rendered, but this has mostly broken away (Figure 4). The remaining render on the face has no aggregate and appears to be part of a later repair.

Figure 2: Small pebble aggregate and cracking at the edge of the landing.

RJC stonemasons should be consulted to advise on the concrete mix so that an appropriate match is made, in line with the approved methodology for repairs to other parts of the Hickson Road retaining wall.

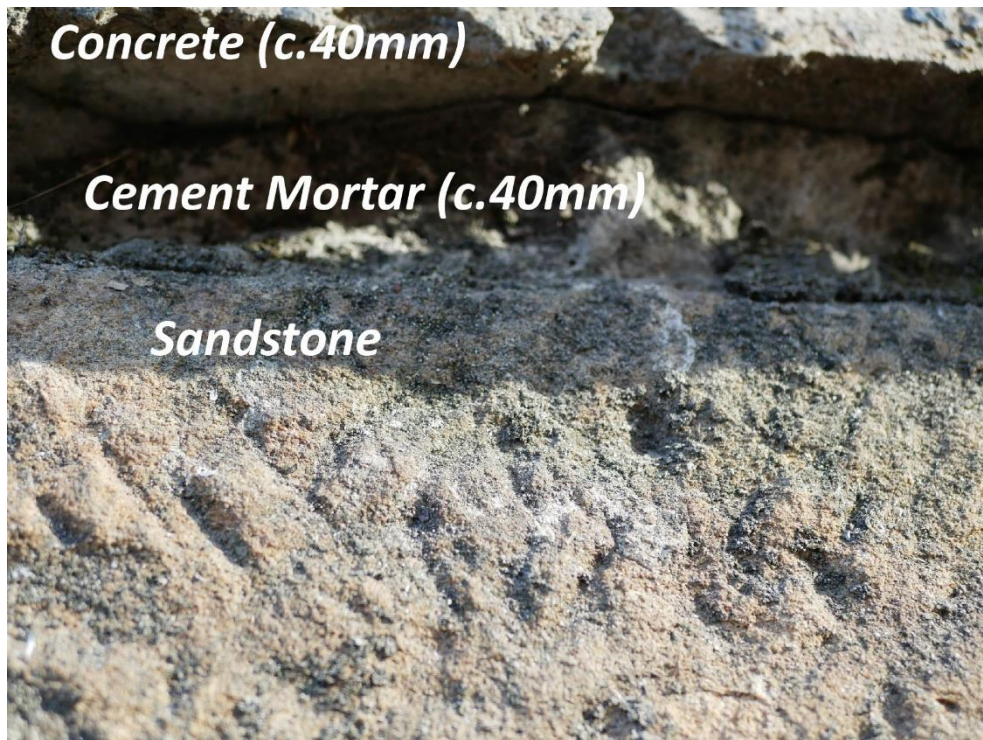
Figure 3: Detail showing the layers of construction within the landing surface.

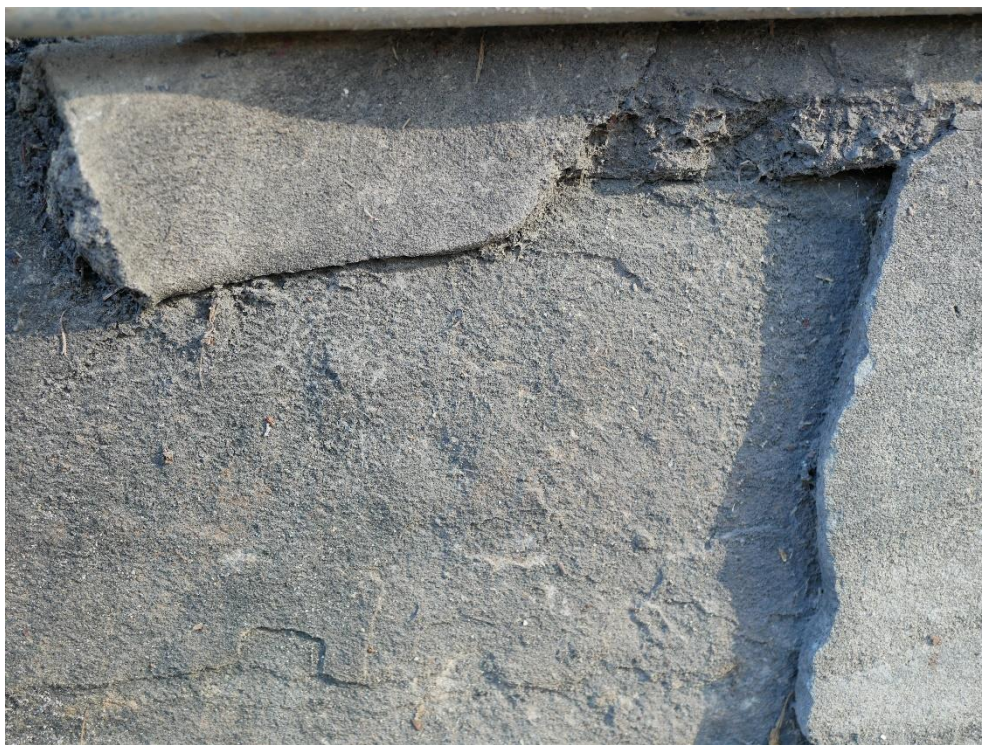
Figure 4: The remaining render on the Hickson Road face of the landing step does not appear to be original and has no aggregate.
