7 March 2025  
Ref: 170108-ER\_DPHI Feb 2025

**RE: Sydney Metro City and South West – ER Monthly Reports for February 2025**

The attached summaries detail the key activities undertaken by Environmental Representatives for Sydney Metro – City and South West Sydenham to Bankstown for the month of **February 2025**.

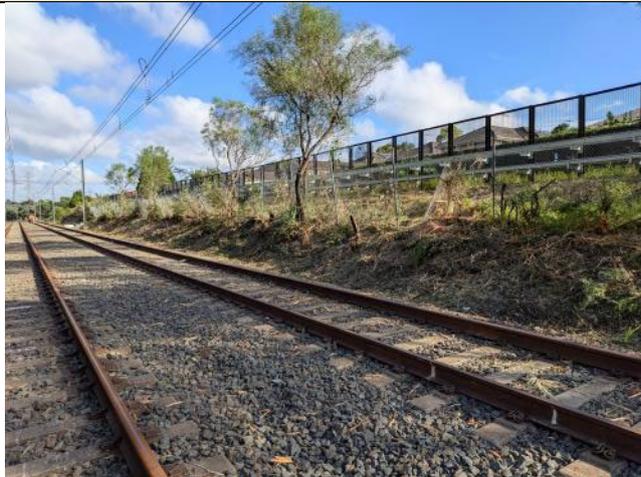
**Figure 1 – Punchbowl** – Ongoing vegetation removal works.

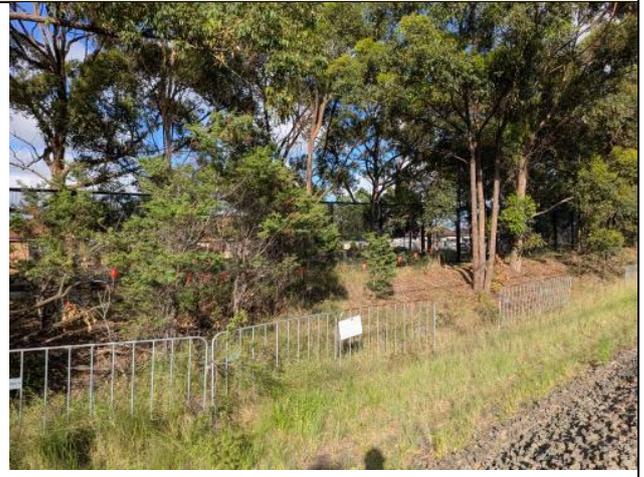
**Figure 2 – Punchbowl** – Damage to Acacia Pubescens identified by JHLOR.

- 03/02/2025 – Damage to *Acacia Pubescens*

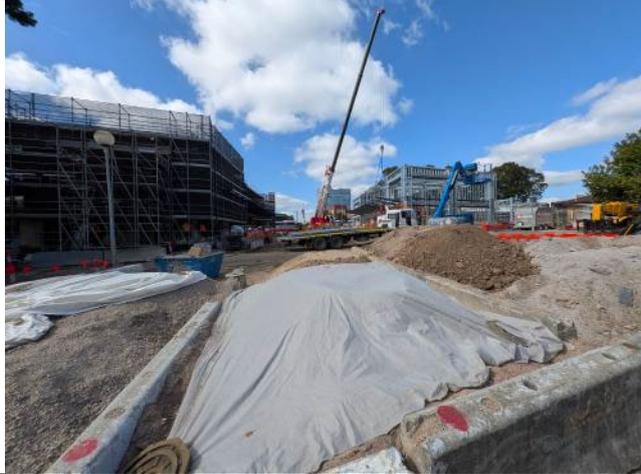
**Figure 3 – Bankstown** – Material laydown area in use.

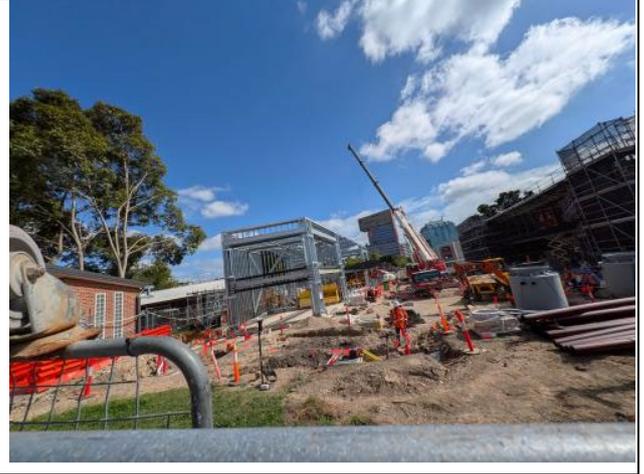
**Figure 4 – Sydney Trains side plaza structural steel works in progress.**

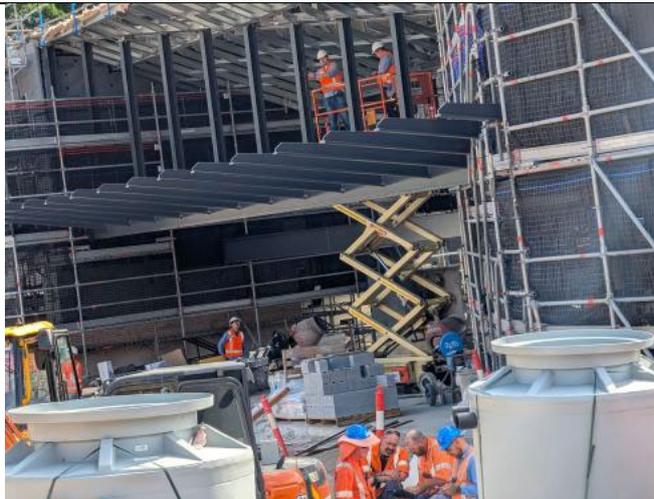
**Figure 5 – Sydney Metro building brick works and block works in progress.**

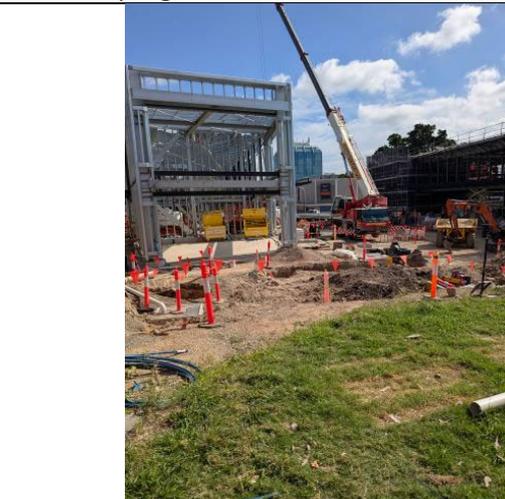
**Figure 6 – Combined services route installation ongoing.**

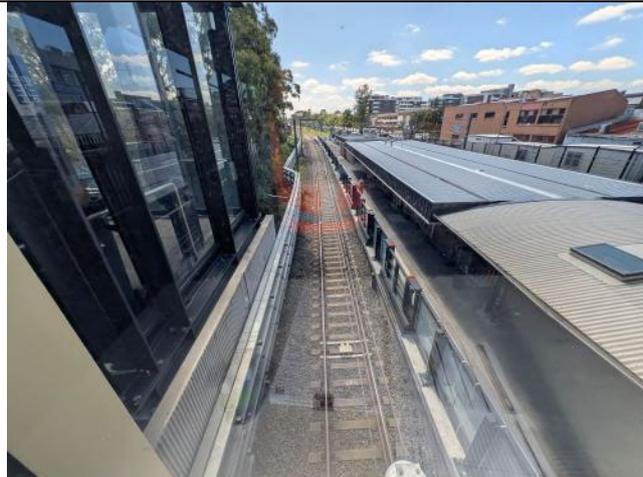
**Figure 7 – Punchbowl Station** - Platform screen doors, mechanical gap fillers and roof works completed.

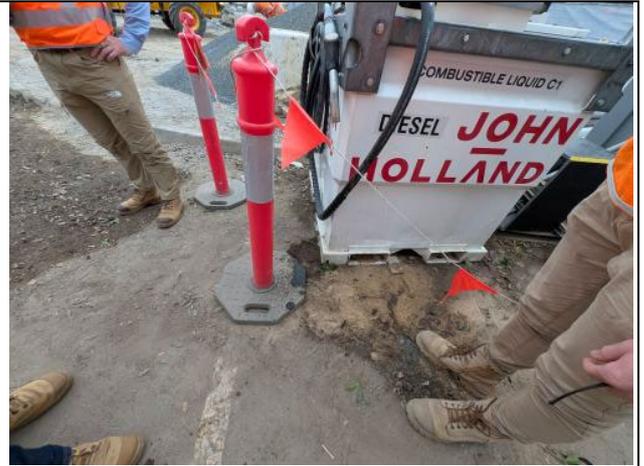
**Figure 8 – Bankstown Station** – Minor fuel spill was observed from refuelling tank.

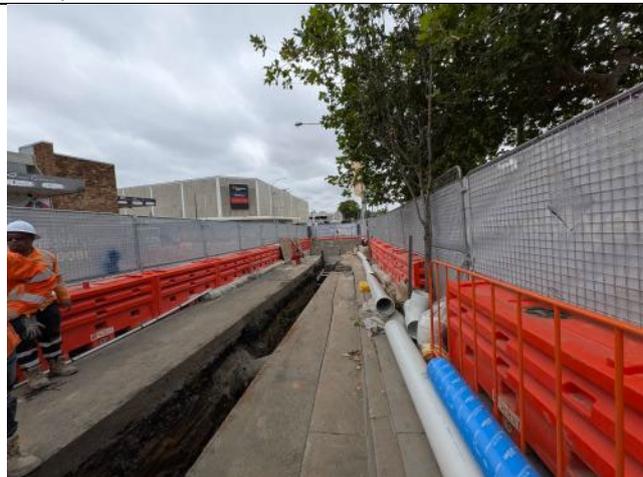
**Figure 9 – Bankstown Station** – South Terrace – Sewer works ongoing.

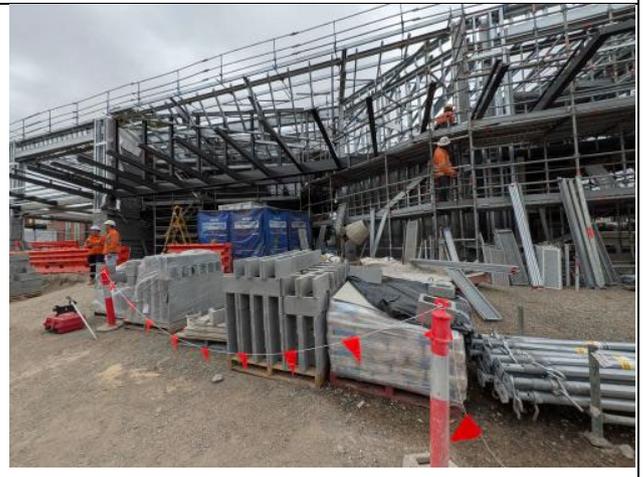
**Figure 10 - Sydney Trains side plaza** structural steel, brick works and block works in progress.

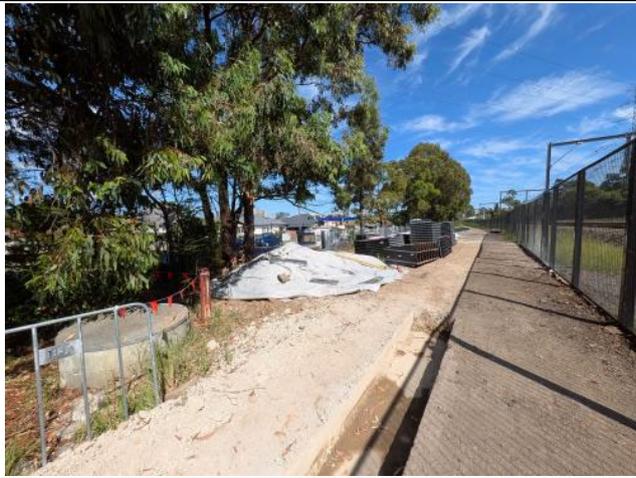
**Figure 1 – Barrier installation works at Carnation Ave.** TPZ in place however some stockpiles were observed under drip line of trees which were later relocated elsewhere.

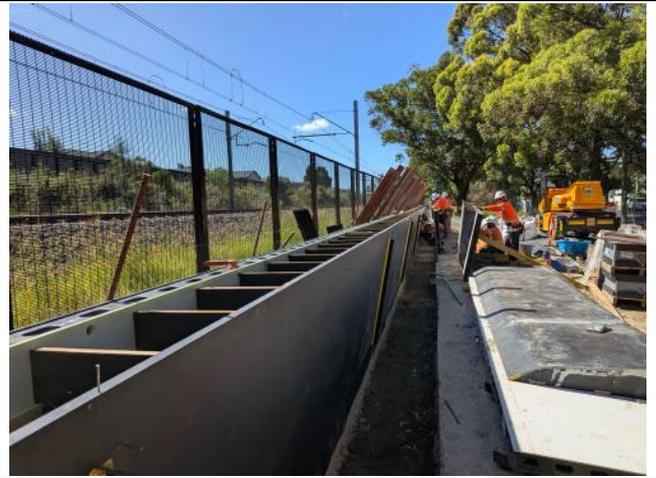
**Figure 2 – Carnation Ave – Barrier installation works ongoing including formwork and concrete pours.**

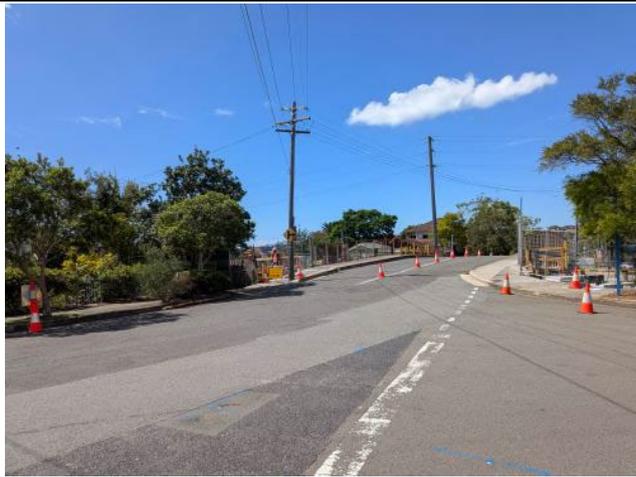
**Figure 3 – Melford St – TMP implementation, piling works completed with barrier installation upcoming.**

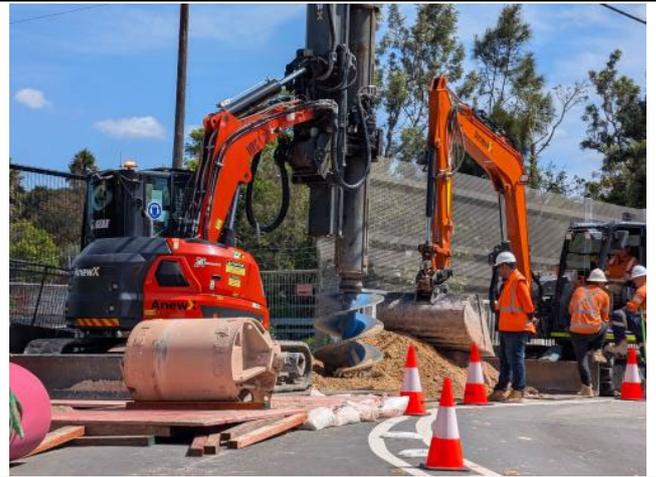
**Figure 4 – Albermarle St - Ongoing piling works on Albermarle St bridge. Excavated spoil being managed with trucks for reuse at other sites or offsite disposal pending results.**

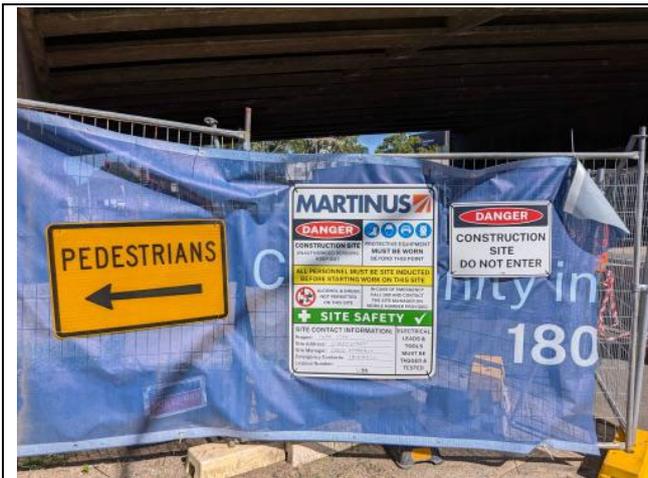
**Figure 5 – Stacey St** - Bridge protection works upcoming. Signs and shade cloth in place around the work site. Temporary pedestrian diversion in place around the Stacey St site.

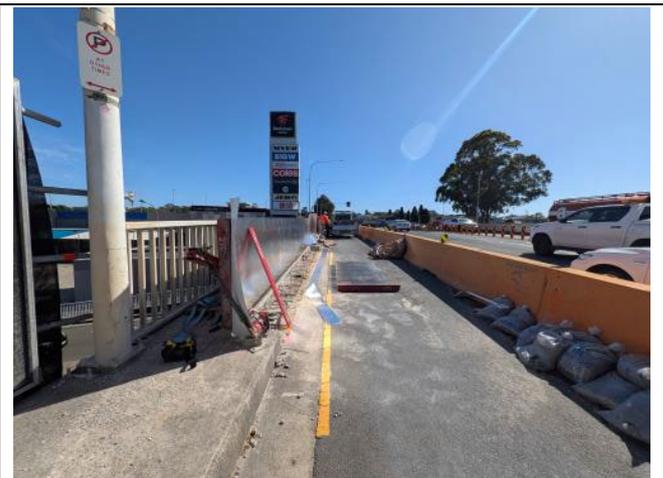
**Figure 6 – Stacey St** - TMP implemented, hydro demolition works completed, footpath extension works ongoing stages. No sign of concrete slurry impacts to nearby stormwater drains. Coir logs were observed around the stormwater drains.
