7 April 2025 Ref:201209-ER\_DPHI-March 2025

# RE: Sydney Metro - Sydney Metro Western Sydney Airport SSI 10051 – ER Monthly Report for March 2025

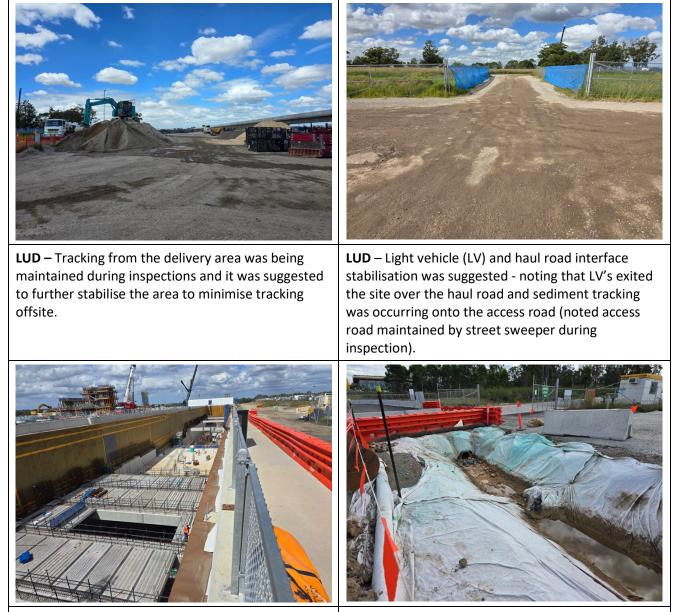
**OHE** – Concrete headwall installed on sump after failure of previous headwall.

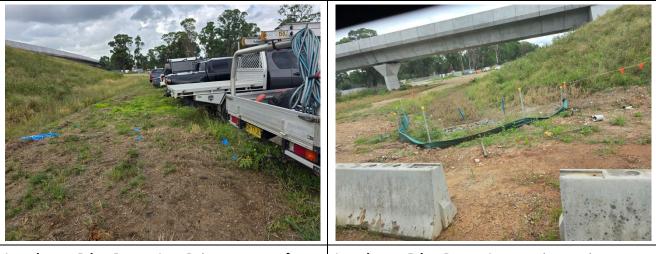
**CMSF** – It was noted that water flow through the material laydown area required maintenance (noting sheet flow had occurred). The ER suggested that surface water drainage be investigated with the CPESC.
