4 July 2025
Ref: 170108-ER_DPHI June 2025

RE: Sydney Metro City and South West – ER Monthly Reports for June 2025

The attached summaries detail the key activities undertaken by Environmental Representatives for Sydney Metro – City and South West Sydenham to Bankstown for the month of **June 2025**.

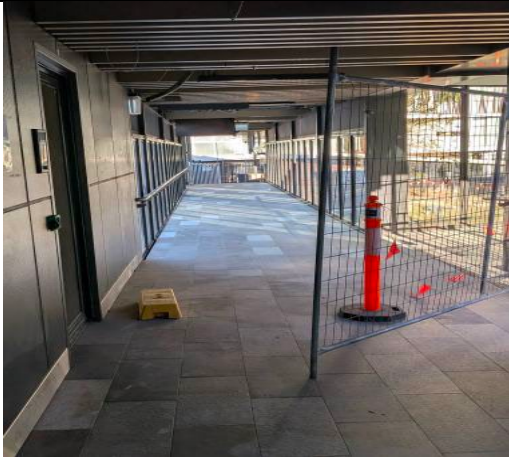
Figure 1 – Canterbury Station – Footbridge works now complete including glass installation and paving. Discussions underway regarding removal of existing balustrade.

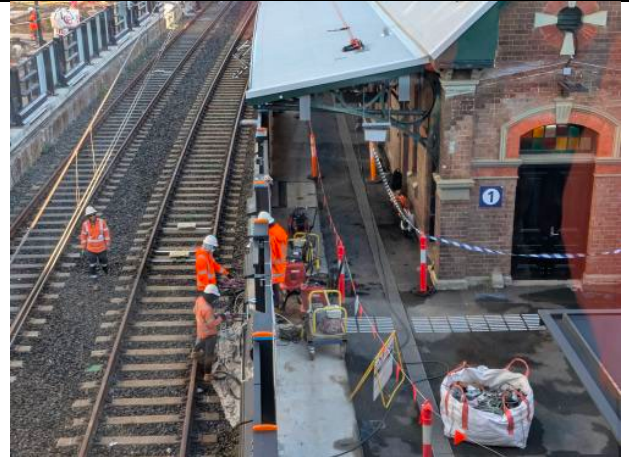
Figure 2 – Canterbury Station – Core drilling underway for Mechanical Gap Fillers (MGF), erosion and sediment controls in place on track and ballast.

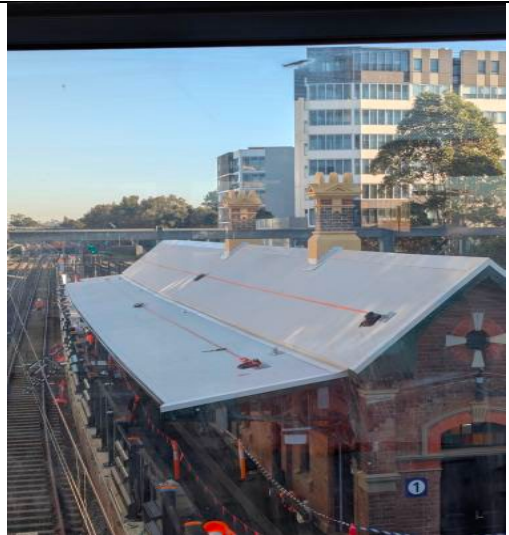
Figure 3 – Canterbury Station – Majority of roof installation is now complete.

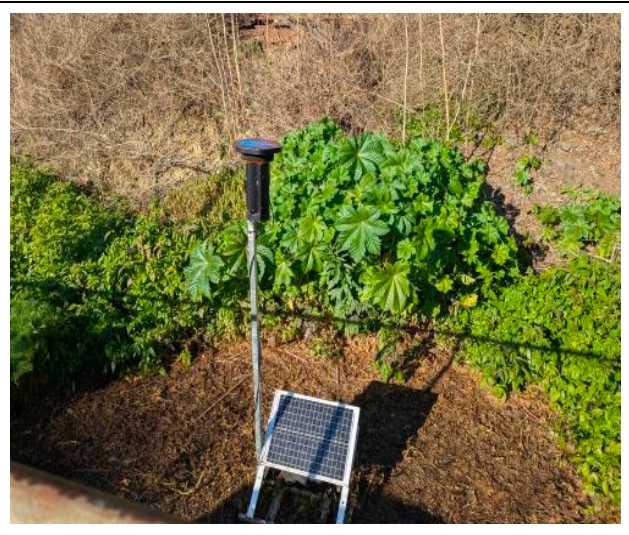
Figure 4 – Bankstown Station - Site hive monitoring ongoing near the commuter carpark for the 63 days shutdown on the Sydney Trains side of Bankstown station. No exceedances and no complaints recorded since the commencement of these works.

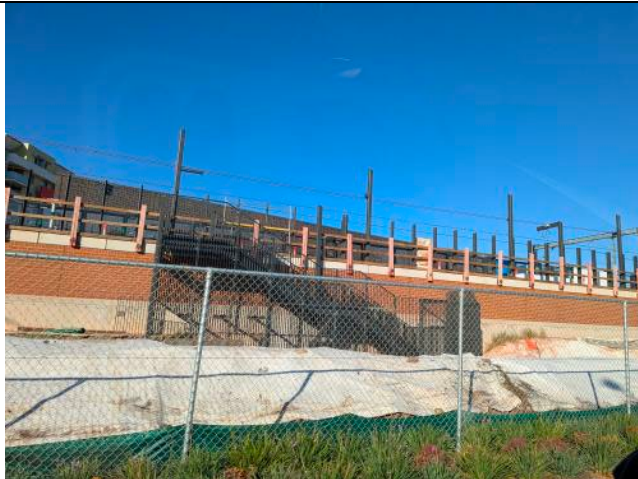
Figure 5 – Bankstown Station – Sydney Metro side platform brick installation works complete.

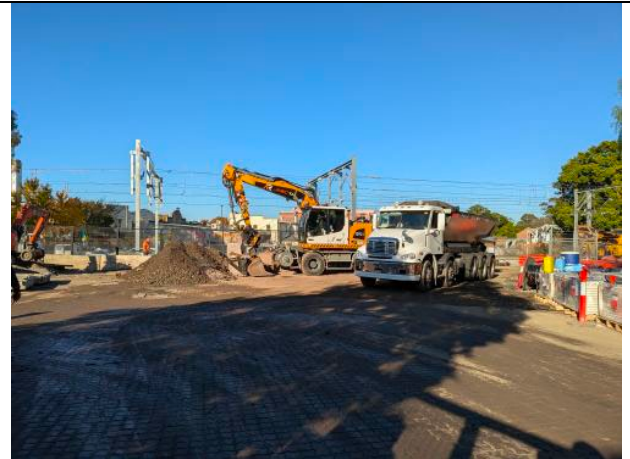
Figure 6 – Bankstown Station – Asphalt deliveries underway for Sydney Trains side platform resurfacing works.

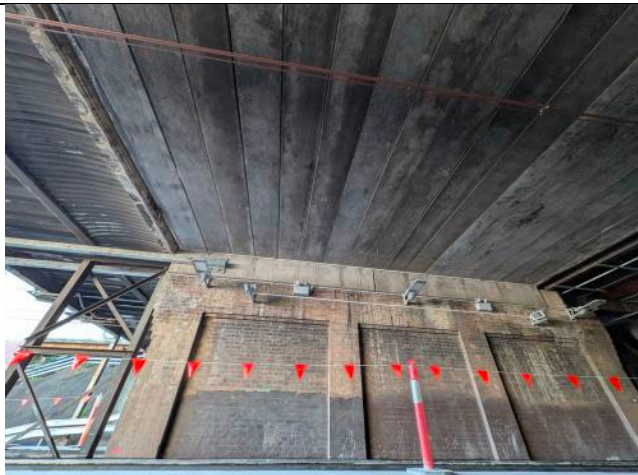
Figure 7 – Bankstown Station – NCR was raised regarding electrical works and impacts to heritage.

- 05/06/2025 – NCR – NAH16 – Fixing of lighting and electrical conduits to heritage fabric at Bankstown Station

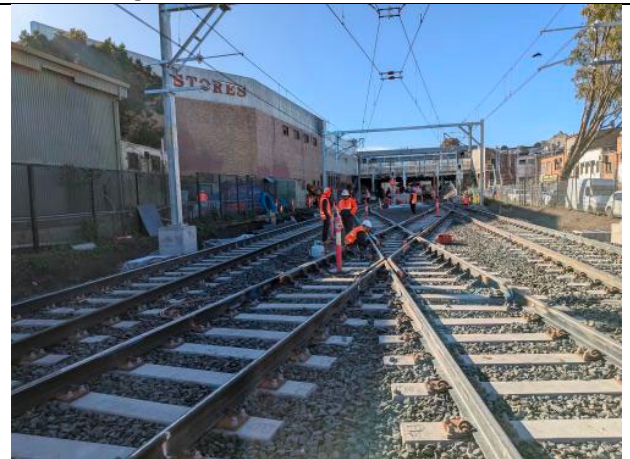
Figure 8 – Bankstown Station – Trackworks nearing completion. Installation of track turnouts, ballast, sleepers, surface drainage, intertrack drainage, overhead wiring, signals and components as well as trackside equipment has been recently completed.

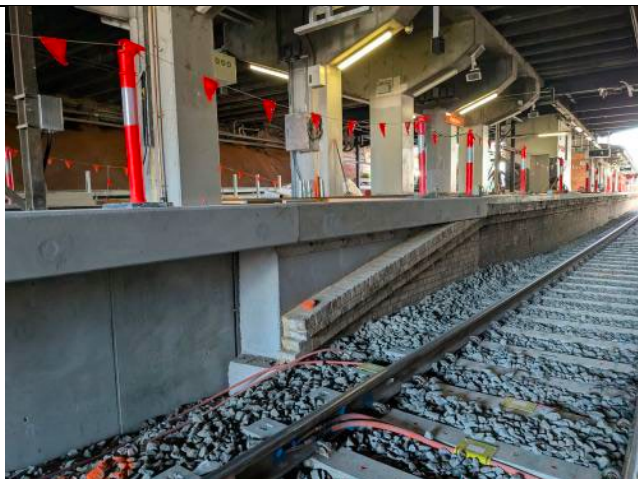
Figure 9 - Bankstown - Sydney Trains side platforms – heritage interpretation.

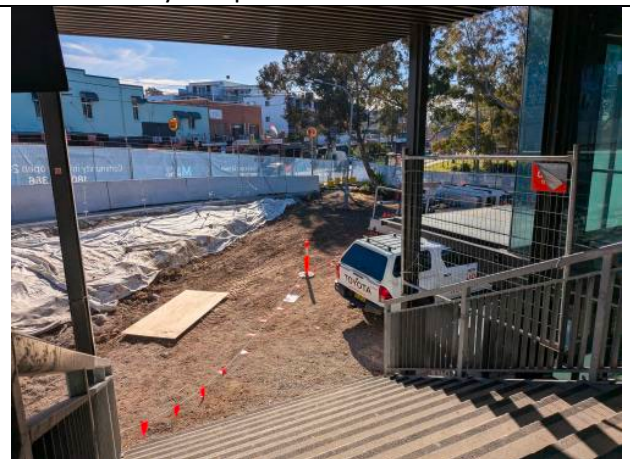
Figure 10 – Punchbowl – Landscaping works underway.

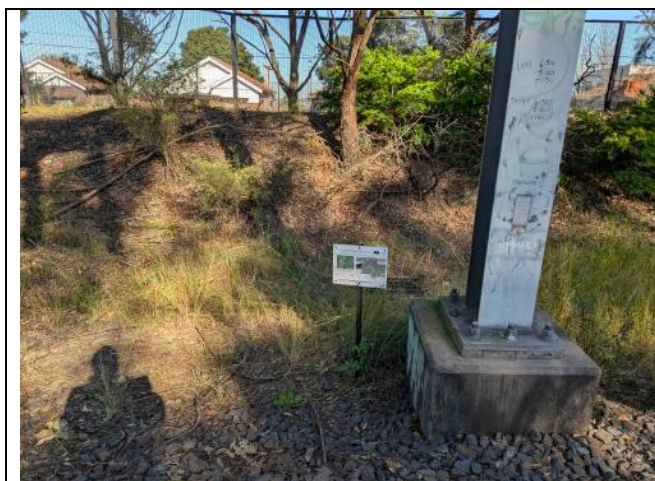
Figure 11 – Punchbowl – Vulnerable species notice on display to inform work crews regarding environmental sensitivities within the rail corridor and hold point details. Downy wattle was observed growing in the ballast within the rail corridor. Further discussions to be held between SM and the operators for future potential issues that may arise due to this vulnerable species sightings in ballast and operation zone.

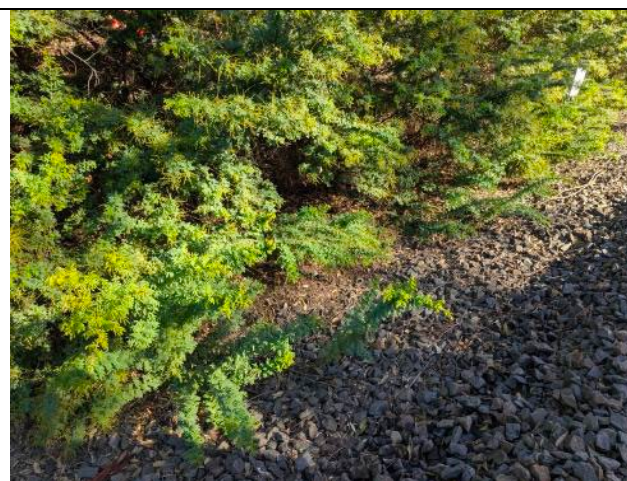
Figure 12 – Punchbowl – Downy wattle was observed growing in the ballast within the rail corridor. Further discussions to be held between SM and the operators for future potential issues that may arise due to this vulnerable species sightings in ballast and operation zone.

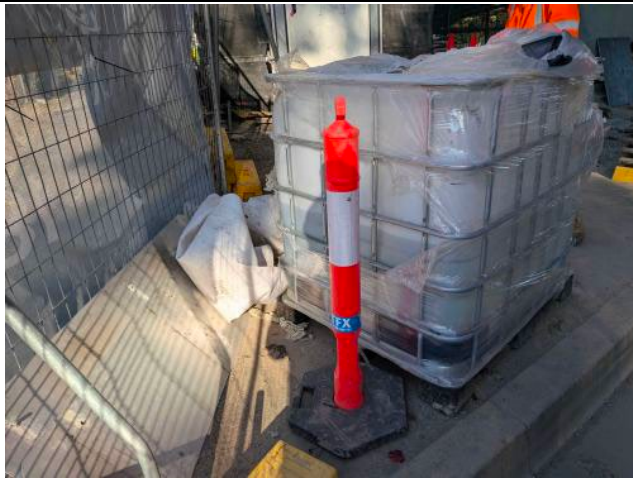
Figure 1 – Stacey St, Bankstown – Unknown, unlabelled, unbanded Intermediate Bunded Container (IBC) was observed to be stored underneath Stacey St bridge works area. Martinus to ensure all dangerous goods and chemical containers are appropriately labelled and banded.

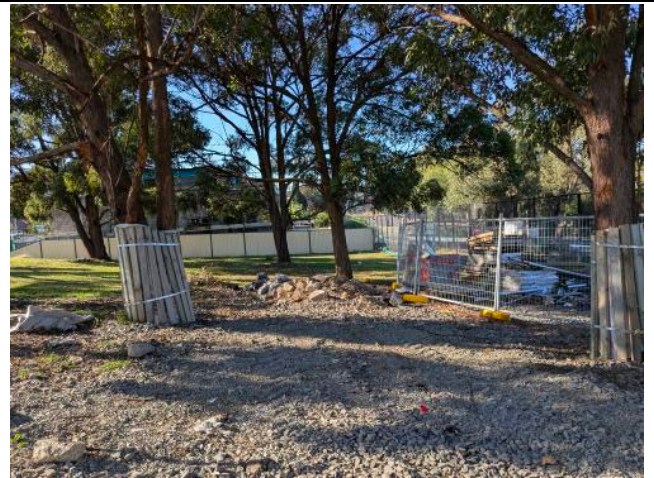
Figure 2 – Stacey St, Bankstown – Within the approved minor ancillary facility area at North terrace, unsecured stockpiles of spoil and rock/concrete were observed nearby trees adjacent to the North Tce site compound, Martinus to advise disposal timeframe. There is a risk of these stockpiles to be tampered with since they are outside site compound ATF area.

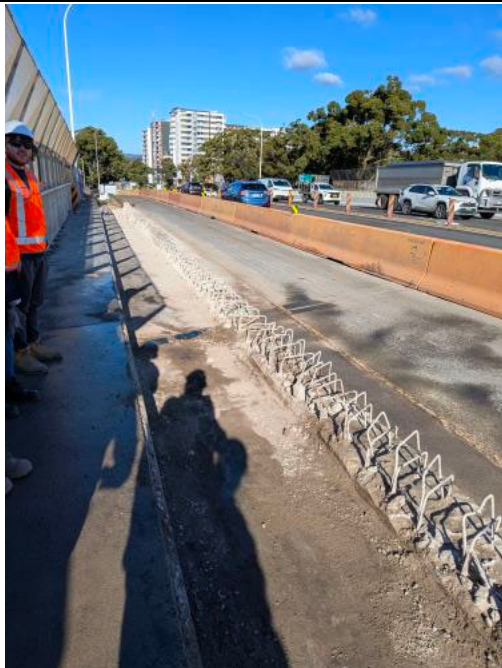
Figure 3 – Stacey St – Stage 2 Footpath works ongoing.

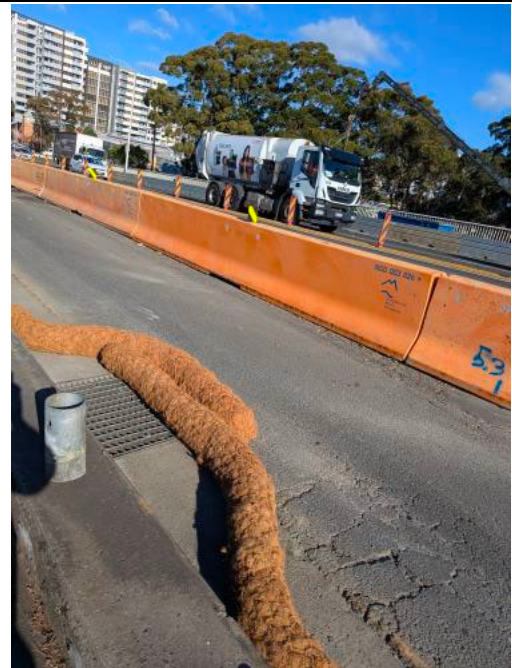
Figure 4 – Stacey St overbridge – ERSED controls in place and refreshed recently.

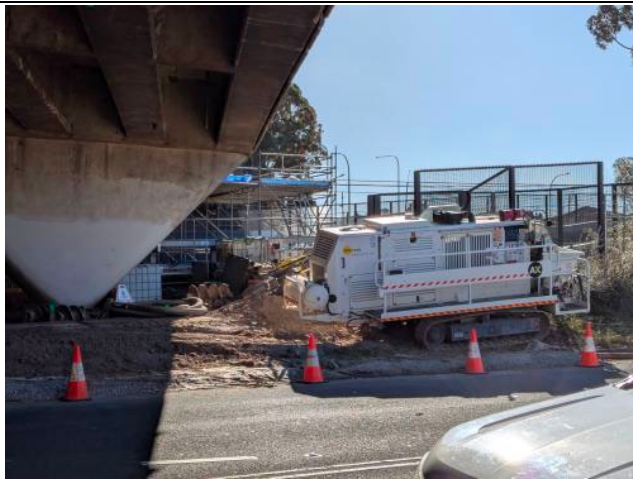
Figure 5 – South Tce – At South Tce worksite location, it was noted that excavation and preparation works for piling had begun.

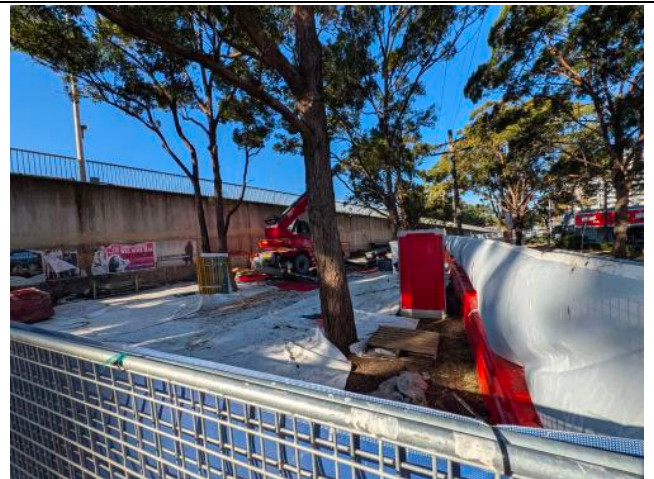
Figure 6 – South Tce – Minor Ancillary Facility in use.

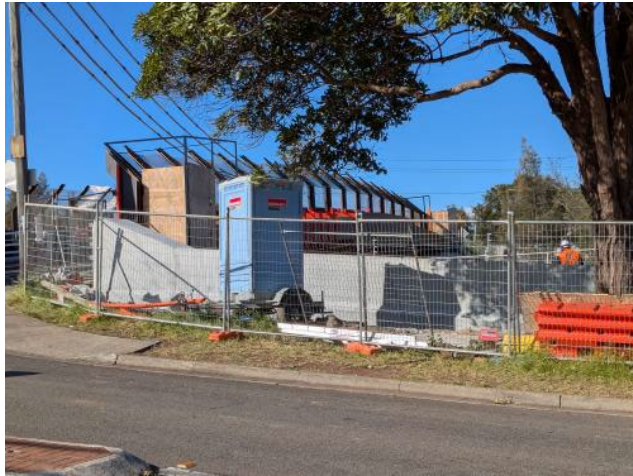
Figure 7 - Moreton St, Lakemba - Bridge girder placement completed in WE52, concrete barrier works ongoing.

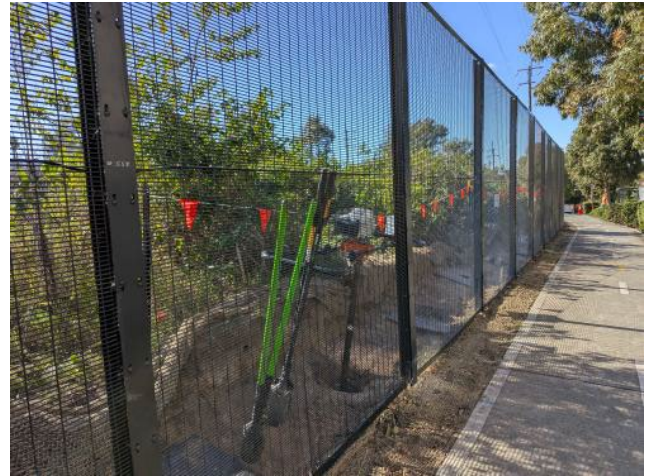
Figure 8 – Dudley St, Dulwich Hill – Steel barrier installation works commenced adjacent to the PCT area. Good practice noted on site including appropriate signage in place around PCT at Dudley St, Dulwich Hill and all workers have been inducted/informed about the PCT requirements by the project ecologist.
