6 June 2025
Ref: 170108-ER_DPHI May 2025

RE: Sydney Metro City and South West – ER Monthly Reports for May 2025

2. Southwest Metro Corridor Package 3 (SWM3) JHLOR

3. Errant and Hostile Vehicle Mitigation Treatments (EHVMT)

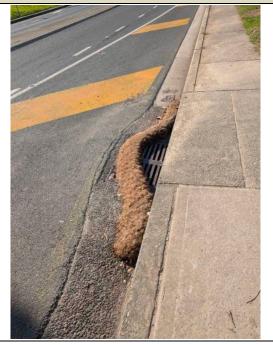
Figure 1 – Stacey St, Bankstown – Erosion and sediment controls in place around stormwater drains.

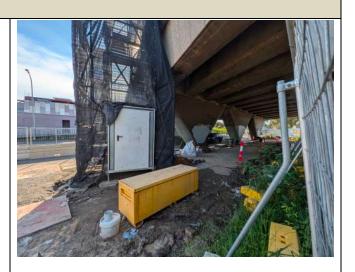
Figure 2 – Stacey St, Bankstown – Planning for bridge protection works underway.

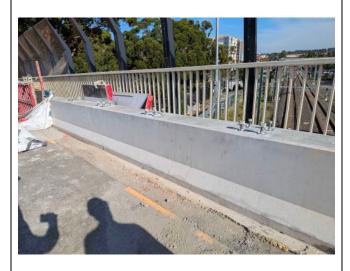
Figure 4 – Stacey St overbridge - FRP and excavation works underway.

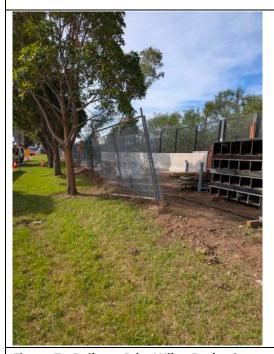
Figure 7 - Railway Pde, Wiley Park - Concrete barrier installation nearing completion.
