5 September 2025

Ref: 170108-ER_DPHI Aug 2025

RE: Sydney Metro City and South West – ER Monthly Reports for August 2025

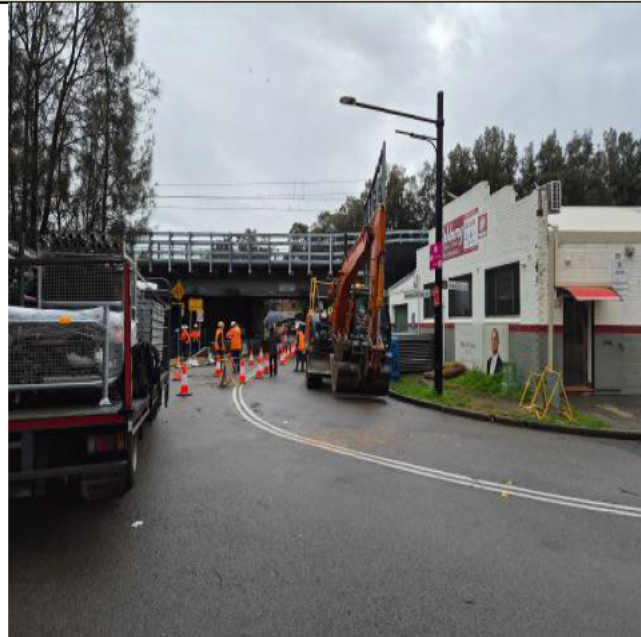
Figure 1 – Charles St – Traffic Management Plan/Traffic Control Plan Implementation completed at the Charles St crash beam installation site.

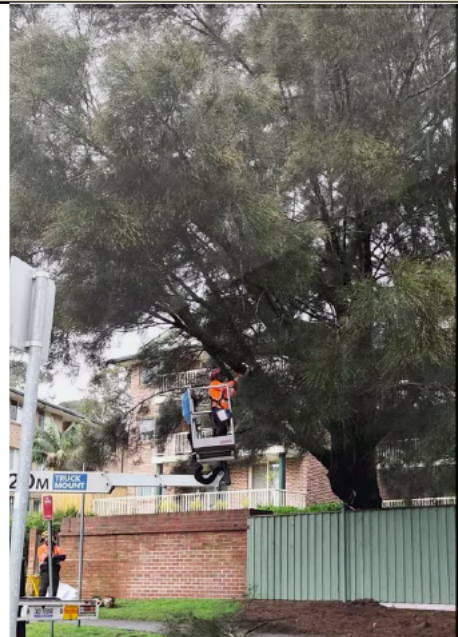
Figure 2 – Charles St – Tree trimming works being undertaken.

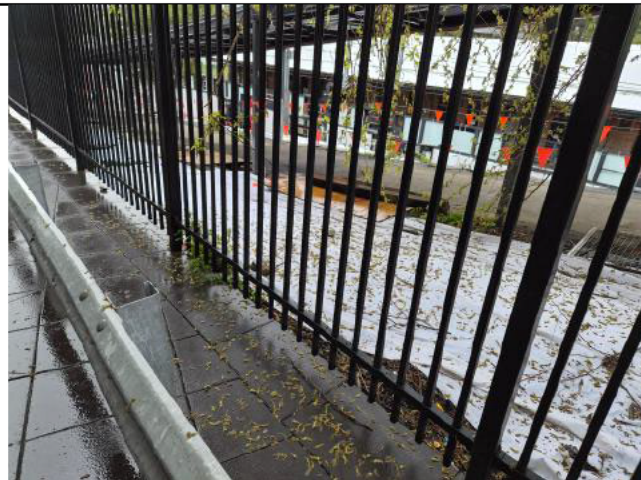
Figure 3 – Canterbury Station - Erosion controls installed on the embankment near the pedestrian ramp.

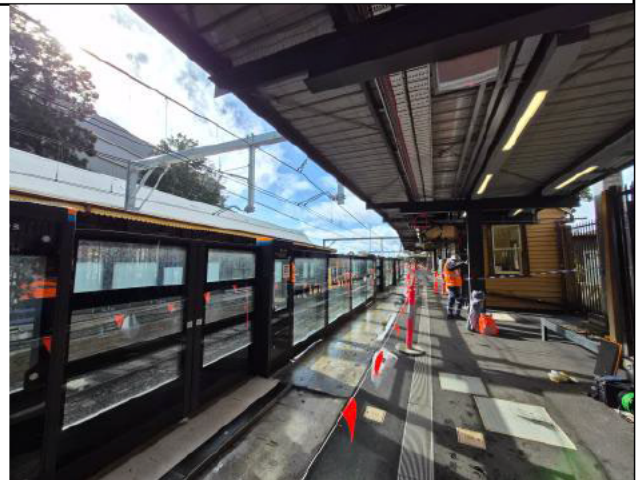
Figure 4 – Marrickville Station - Asphalt removal and majority of works completed at Marrickville Station.

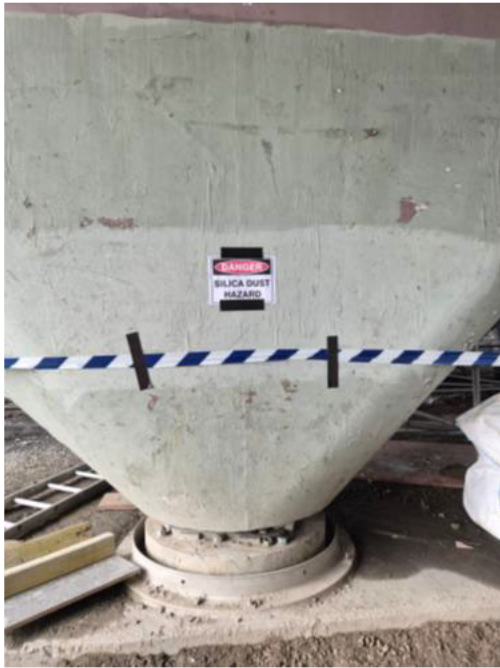
Figure 1 – Stacey St, Bankstown – Bridge modification works commenced.

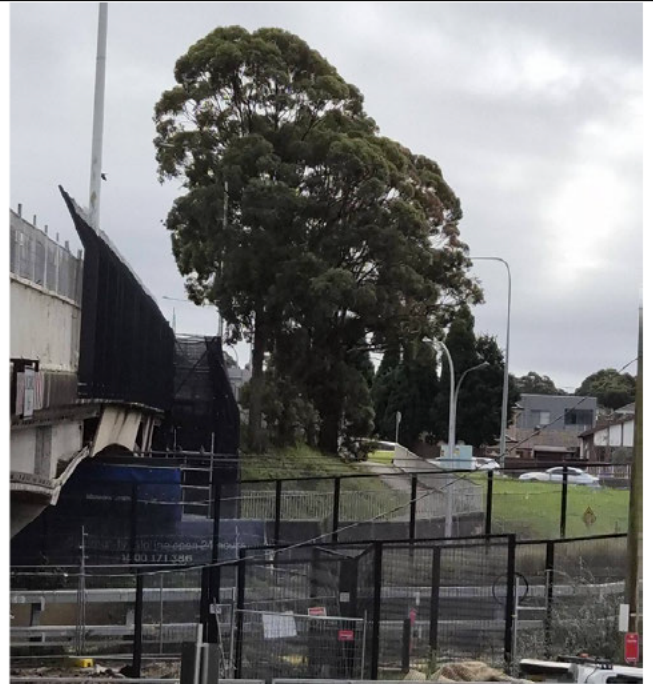
Figure 2 – Stacey St, Bankstown – Panel removal from Stacey St Overbridge ongoing.

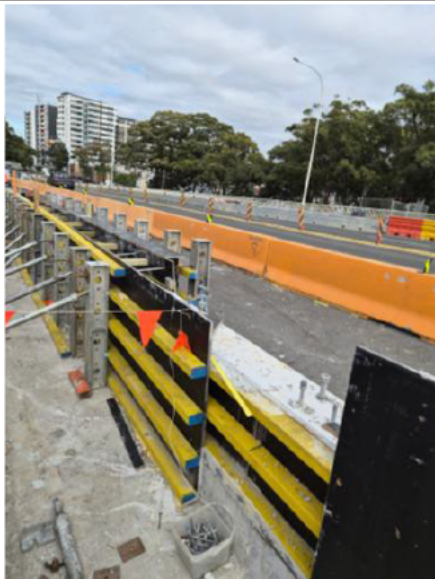
Figure 3 – Stacey St – Stage 2 – Hydro demolition of existing footpath and kerb complete, Footpath works including form, reo and pour (FRP) ongoing.

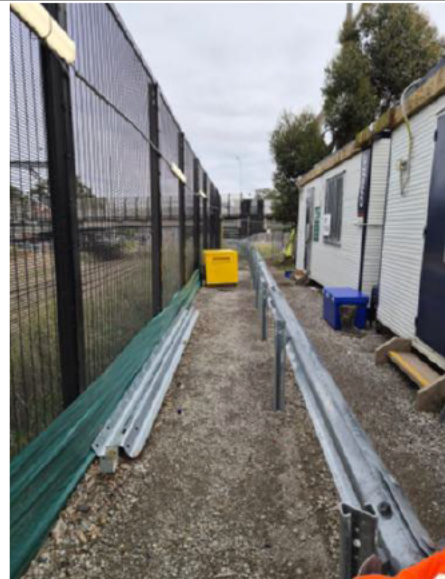
Figure 4 – Stacey St compound – Steel barrier installed near Stacey St compound. Stacey St compound to be demobilised prior to December 2025 (exact date to be confirmed).

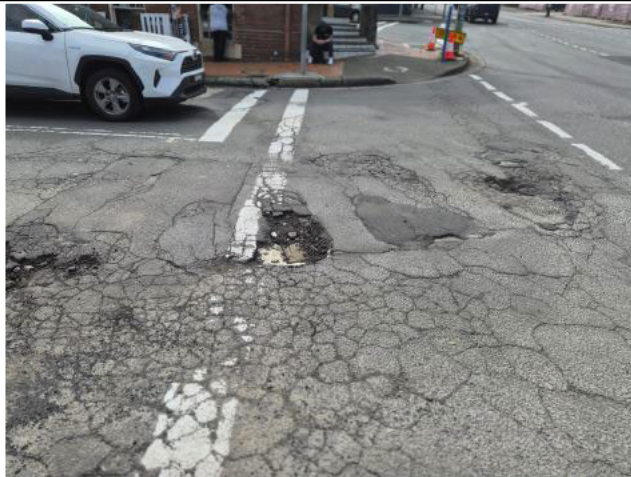
Figure 5 – Canterbury Rd, Canterbury - Bollards installed. Footpath and Sydney water asset relocation related investigation works ongoing. Unexpected finds identified during non-destructive excavation using vacuum truck. Area backfilled and heritage specialist is scheduled to attend site.

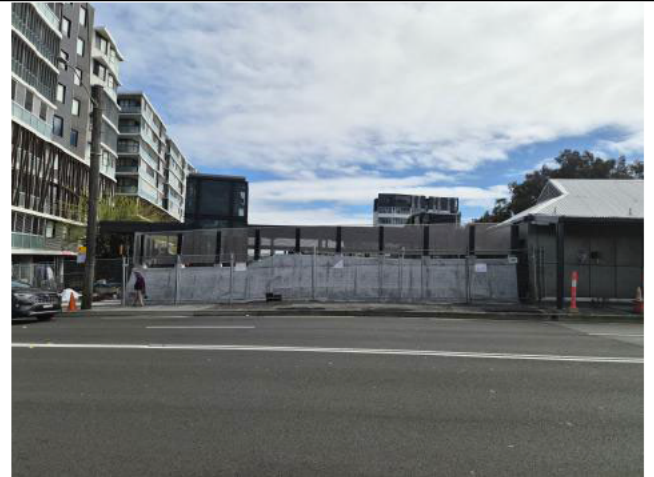
Figure 6 – Canterbury Road, Canterbury - Anti-throw screen installation completed on the station side.

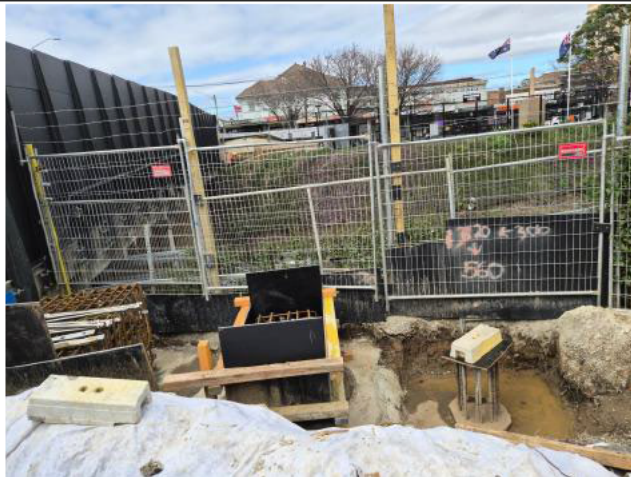
Figure 7 – Haldon St, Lakemba – Piling works completed. Form, reo, pour (FRP) works for over structure beam (OSB) ongoing.
