RE: Sydney Metro - Sydney Metro Western Sydney Airport SSI 10051 – ER Monthly Report for April 2025

The attached summary details the key activities undertaken by Environmental Representatives for Sydney Metro Western Sydney Airport for April 2025.

ER Inspections

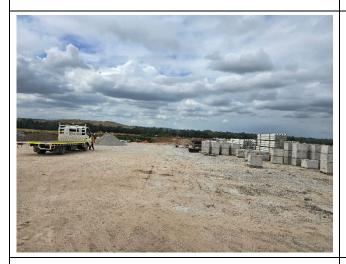
Luddenham to M12 – Bunding of flammable materials in storage laydown area.
