# Planning Approval Consistency Assessment Form

| <b>Assessment Name:</b> | George Street Shops remediation – Part 1B works |

REPAIR WORKS TO EXTERNAL BUILDING FABRIC

## **STATEMENT OF HERITAGE IMPACT**

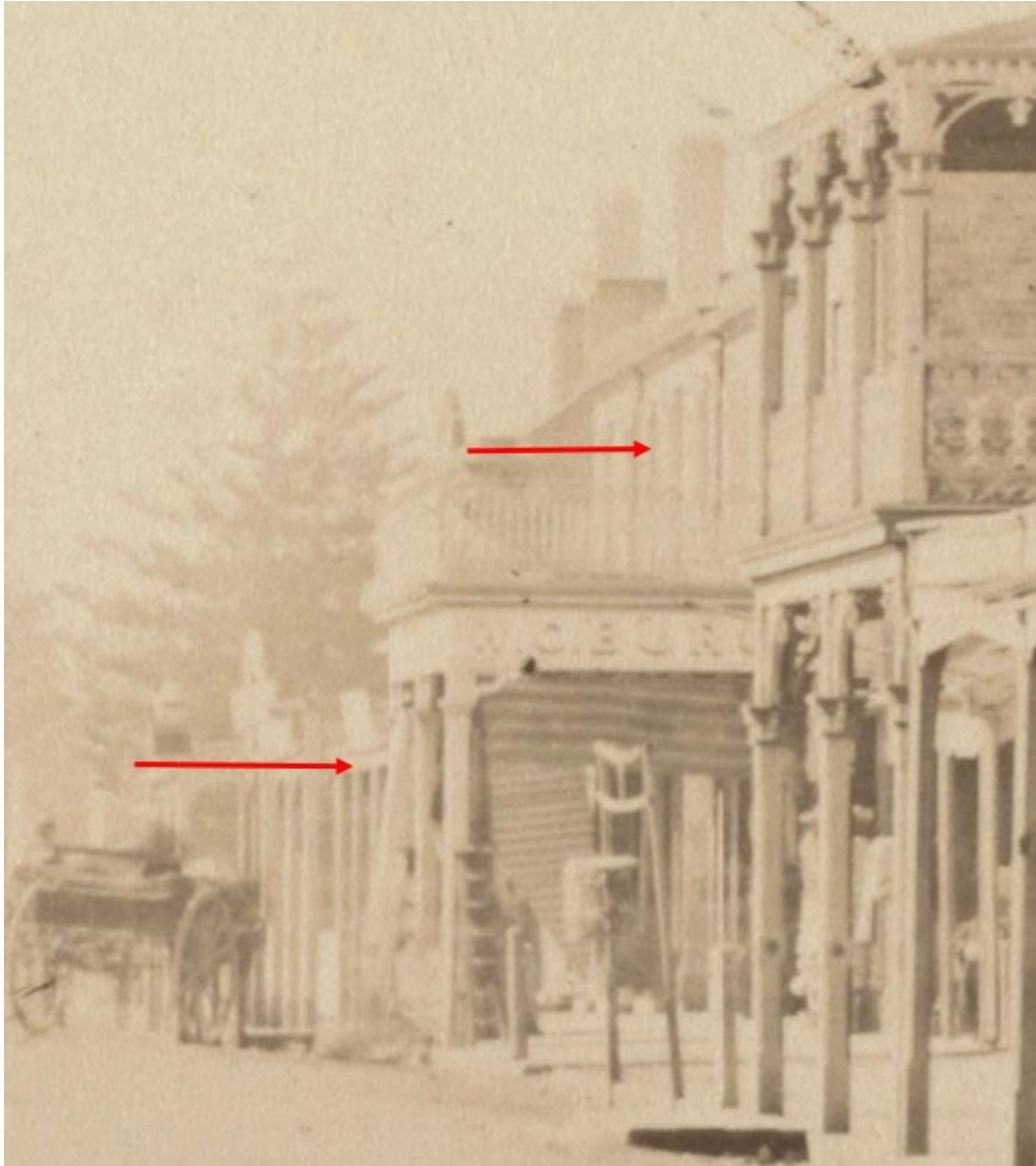
**Figure 2.13:** Excerpt of James Vickers' 1879 photograph of George Street, showing the George Street Shops - indicated by a red arrow - with the post-supported awning indicated by lower red arrow. Source: National Library of Australia.

The equity in the business and property were sold to chemist Samuel Harris in January 1879 and then to Joseph Whitworth of Parramatta in June that same year. The mortgage held by Miller was paid by December 1883 and the interest in the property conveyed to Whitworth.<sup>19</sup> The subject site is seen in a photograph of George Street at that time (refer Figure 2.12 and Figure 2.13).

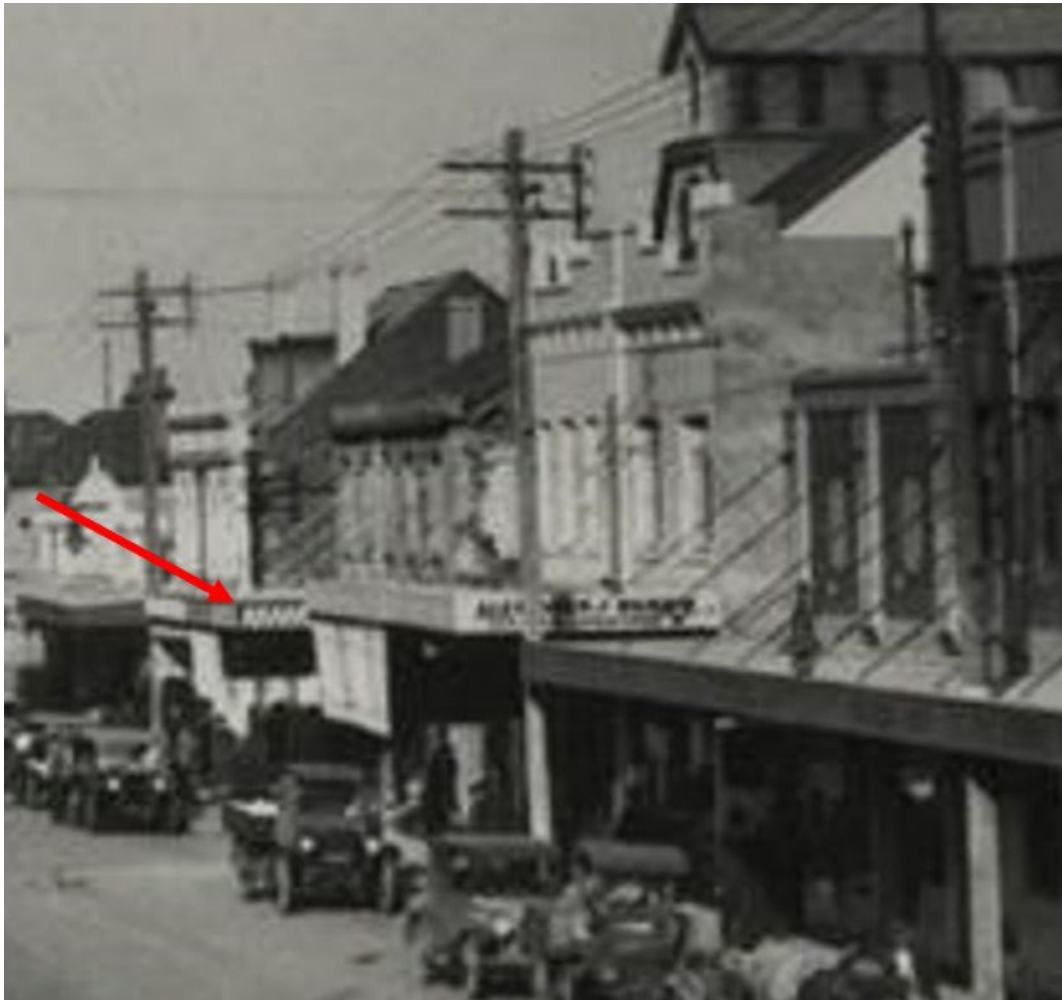
**Figure 2.22:** Detail from Figure 2-21, c.1930s showing suspended awning on the George Street Shops. Source: City of Parramatta, Research and Collections.

At some stage in the early twentieth century, the post supported timber awning was replaced by a suspended awning, with the replacement awning evident in a historical image circa 1930s (refer Figure 2.21 and Figure 2.22). In the block between Church and Smith Streets, the buildings fronting George Street provided a relatively consistent awning over the footpath (refer Figure 2.20 and Figure 2.23).

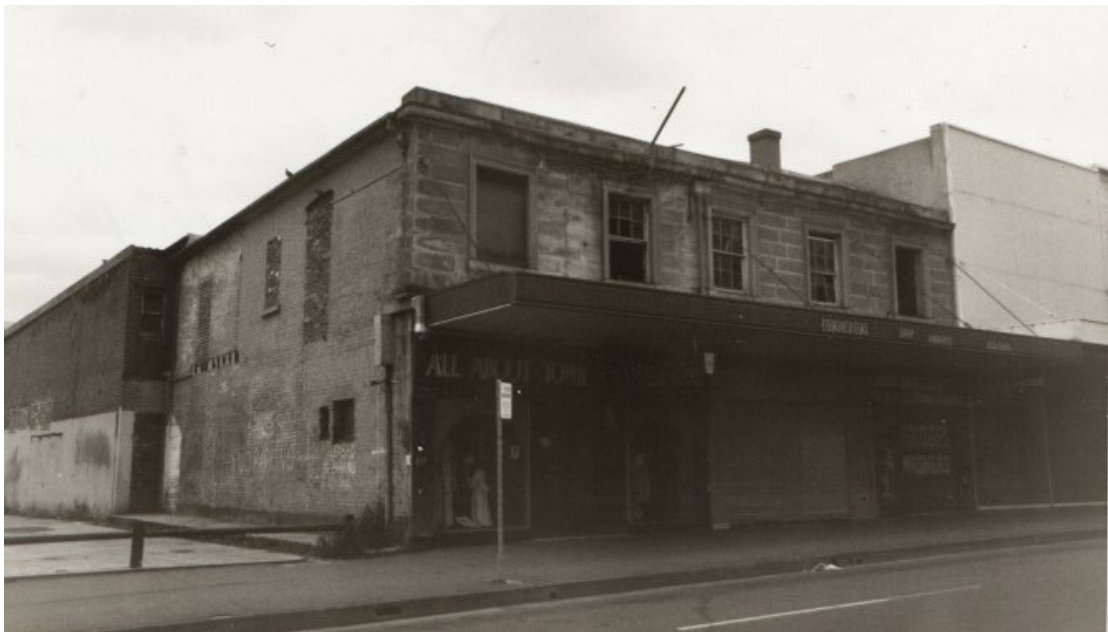
**Figure 2.26:** Undated image of the George Street Shops circa 1970s. Note that the chimney and post supported awning evident in 1877 drawing of Woolcott's Chemist are missing, with the latter component having been replaced by a suspended awning. This image shows the eastern elevation, with openings in accordance with current arrangements. There is evidence of connection to the previous development on the east, in particular a possible walkway from the rear opening indicated by remnant paintwork on the brick around the opening and a series of openings at floor level likely for accommodation of joists. Source: National Trust of Australia.

Around this time, in 1974, the subject site was described as old brick shop and dwelling – with an old brick shed and old irregular galvanised iron shed behind. The building is depicted in an image circa 1970s with suspended awning still extant and chimney missing from the front north eastern corner (refer Figure 2.26). Also shown are openings on the eastern façade with evidence of connection to the previous development on the east. No historic images of the eastern façade prior to the 1970s have been located and no specific evidence has been found to confirm the presence or otherwise of verandah or balcony on the east façade in the early history of the building.

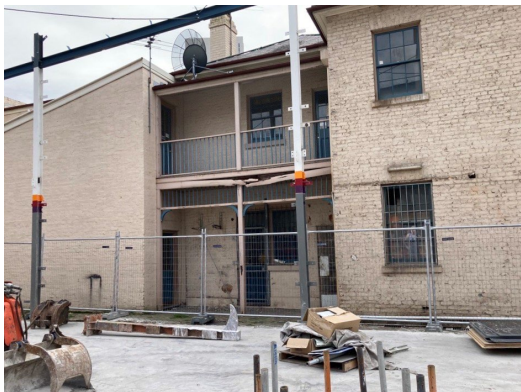
**Figure 2.30:** Rear elevation prior to demolition of two storey toilet wing (left) and rear balcony (centre). Source: Sydney Metro, June 2022.

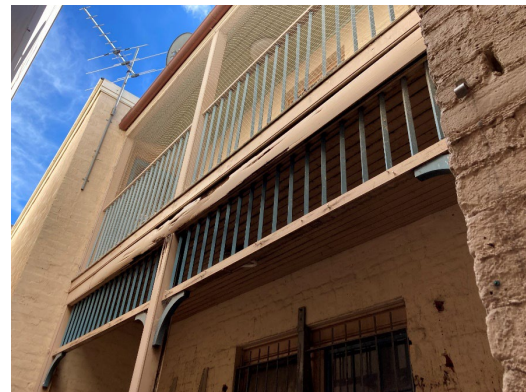
**Figure 2.31:** Detail view of rear balcony prior to demolition. Note non-traditional details and extensive termite damage. The two-storey toilet block addition is partly visible to the left of the image. Source: OCP Architects, 21 April 2022.

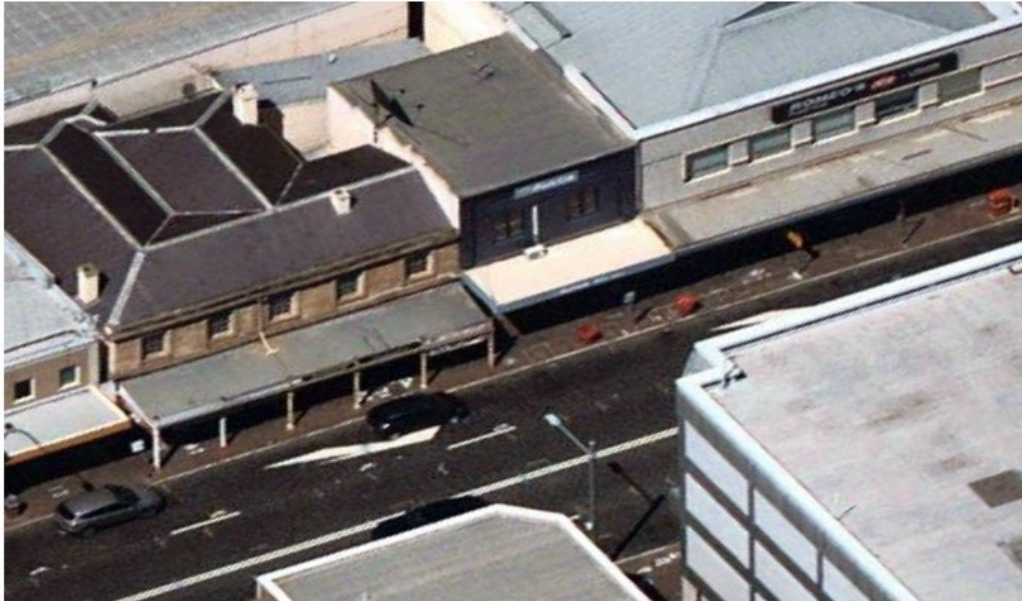
**Figure 3.2:** Oblique aerial image of the subject site from George Street in May 2022, prior to the demolition of the surrounding buildings. View looking southwest, showing the scale and form of the street with two storey buildings with awnings at ground floor level, and offices above on first floor level. Source: Nearmap, May 2022.

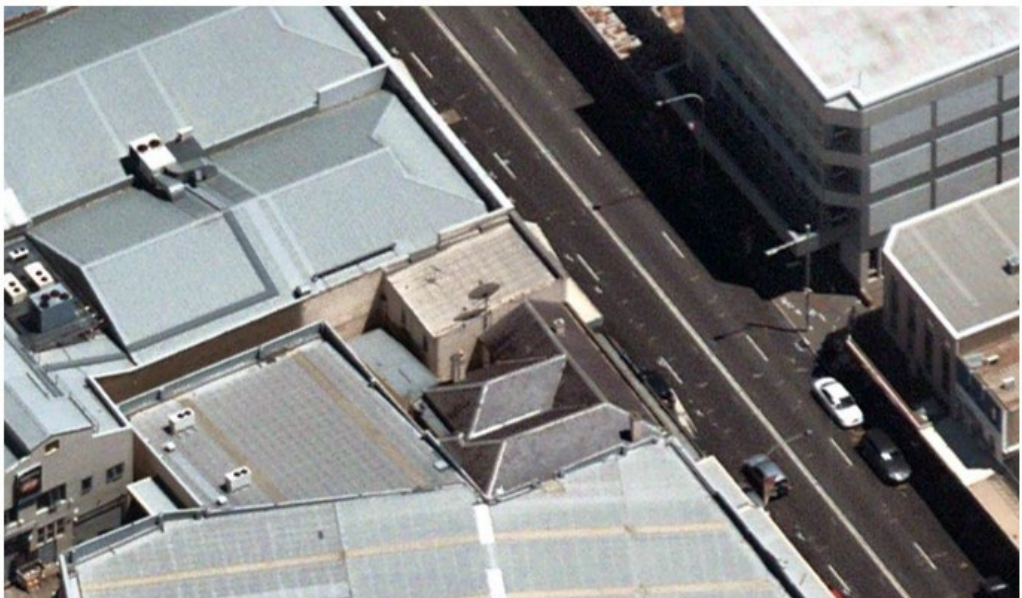
**Figure 3.3:** Oblique aerial image of rear view of the subject site in May 2022, prior to the demolition of the surrounding buildings. View looking northwest, showing three and four storey commercial buildings opposite the subject site. Source: Nearmap, May 2022.

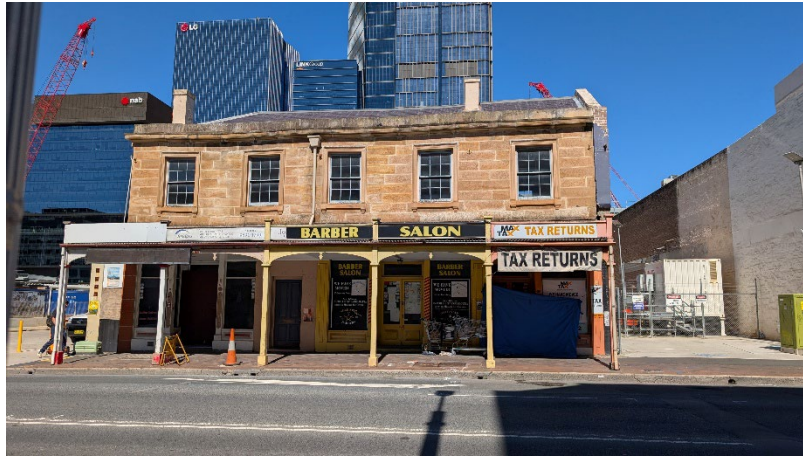
**Figure 3.13:** North façade of the George Street Shops and the post-supported timber awning. Source: OCP Architects, April 2026.

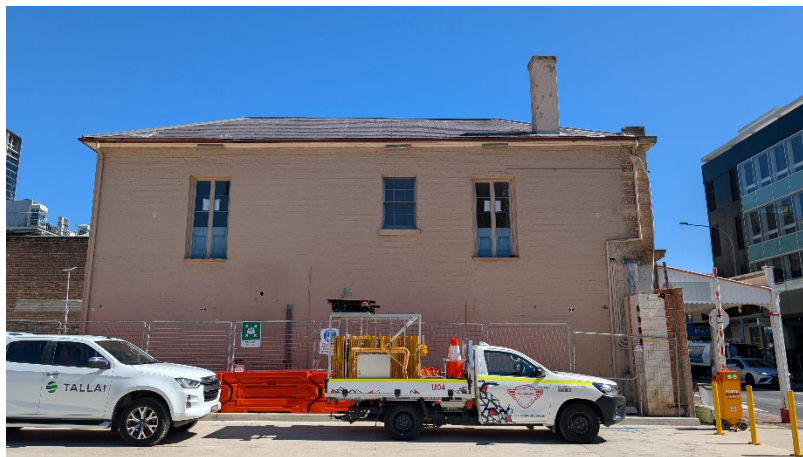
**Figure 3.14:** East façade of the George Street Shops and the post-supported timber awning. Source: OCP Architects, April 2026.

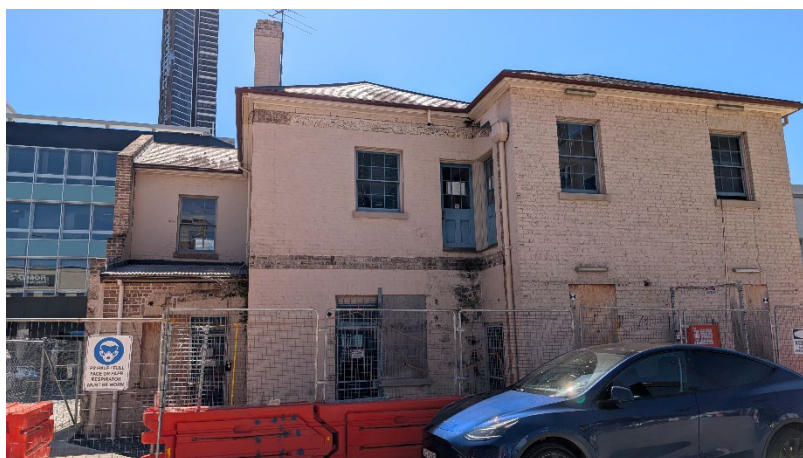
**Figure 3.15:** South façade of the George Street Shops. Source: OCP Architects, April 2026.

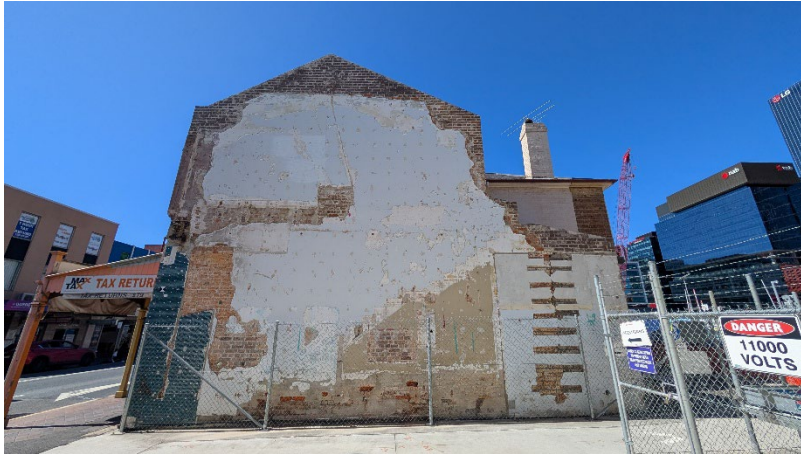
**Figure 3.16:** West façade of the George Street Shops and the post-supported timber awning. Source: OCP Architects, April 2026.
