Independent Environmental Audit on Sydney Metro City & Southwest – TSE Works

Final Report

Contract works: Tunnel, Stations & Excavation Works (TSE)

Scope: Planning Approval compliance relating to Construction Heritage Management

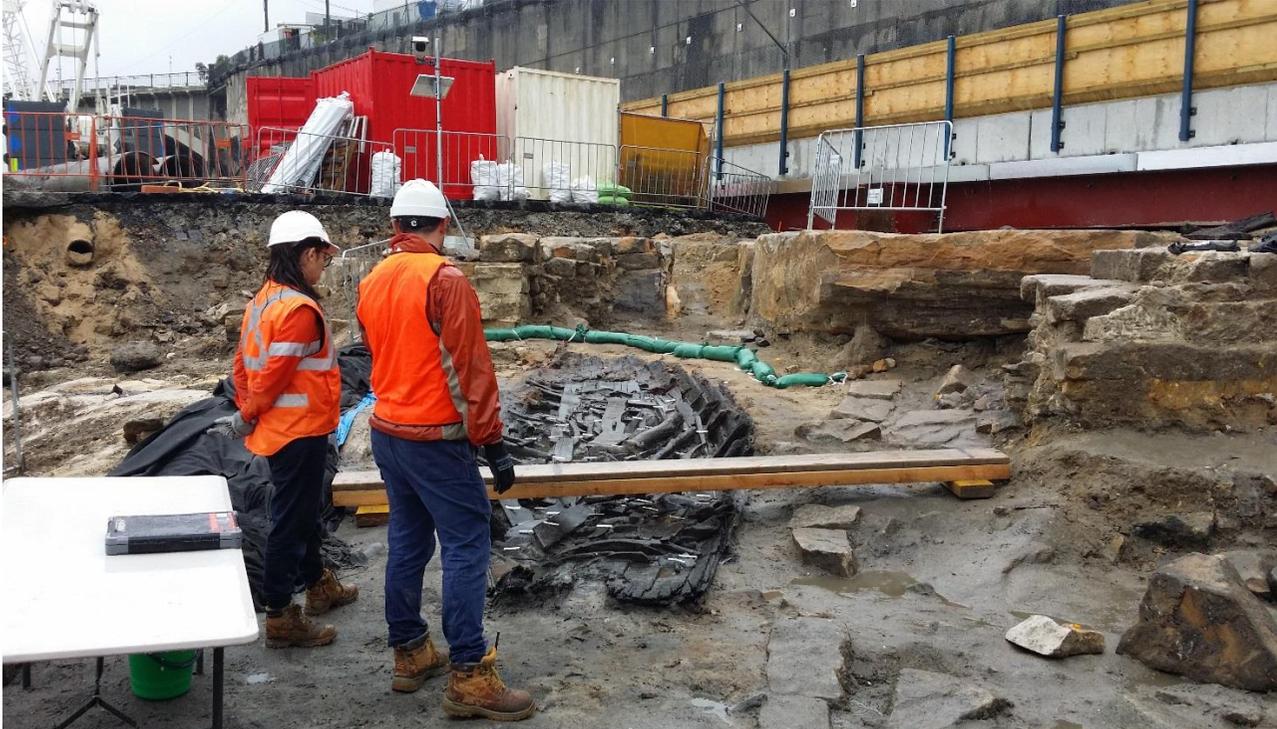
Above: Preparations for archival recording and salvaging of wooden boat hull (Barangaroo)

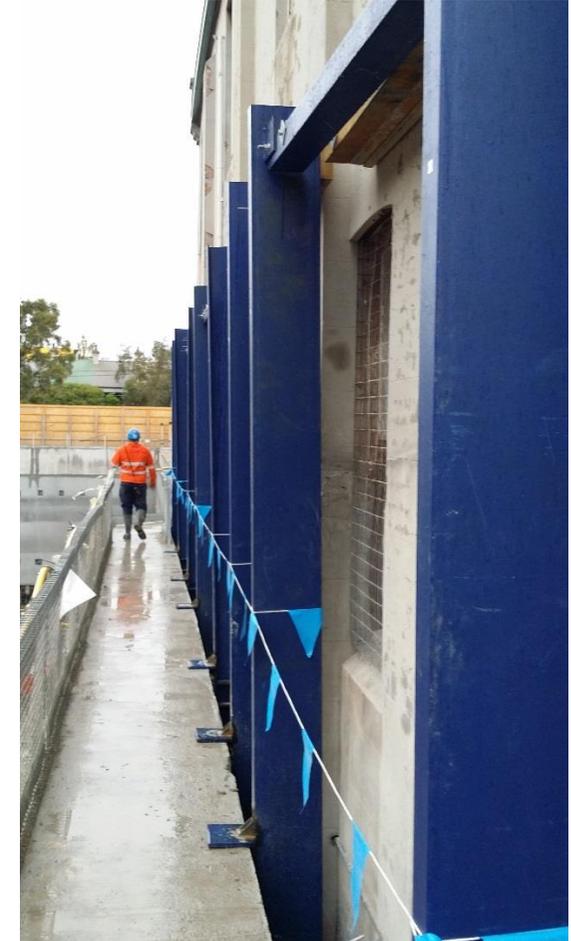
The inspection component of this audit observed the close proximity between the rear wall of the Waterloo Church Annex and the Station Box excavation works, with construction utilising a capped pile methodology. During these works, there had been a few vibration exceedance and ground settlement issues, these assessed by JHCPBG as causing cosmetic damage, this audit noting that subsequent investigations, reports, remedial action and ongoing monitoring were well documented (refer Appendix 1A). As a result of ensuing communications and updates between JHCPBG, Sydney Metro and the Department of Planning & Environment, compliance and project outcomes were therefore not reviewed further in this independent audit. Suffice to say that data on vibration and settlement was available, a Monitoring Action Team (MAT) had been established and Permits to Tunnel (or Excavate) were observed to be comprehensive in the assessment of potential risks. Inputs to this review included vibration, settlement and geotechnical information with review and approval of said PTTs evidencing participation by a number of management and technical functions, including the Independent Certifier and Sydney Metro.

Right (alongside): Steel framework (in blue) as mitigation measure to prevent movement of the Waterloo Church Annex towards the Station Box excavation works (concrete capping beam atop piling, as shown).
