7 December 2021  
Ref: 170108-ER\_DPIE-November 2021

**RE: Sydney Metro City & South West – ER Monthly Reports for November 2021**

Jo Robertson  
Environmental Representative

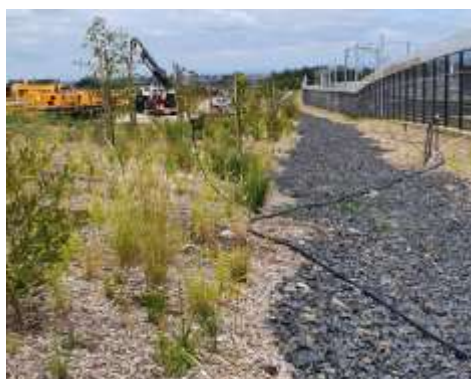
**SMTF North - Landscaping - Planting along northern boundary fence of Snake Mountain observed to be establishing and healthy. Clean water diversion channel and irrigation system remains in place.**

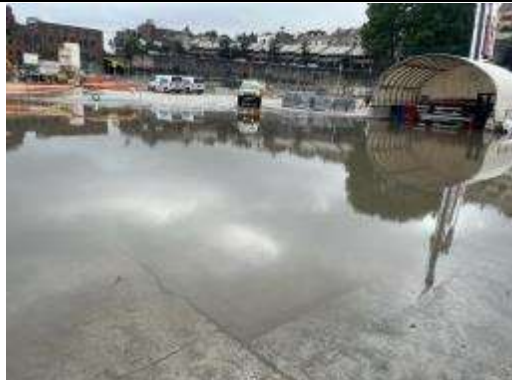
Sheet piling occurring into the 9:30 - 10:30 am respite period	Water pooled in the centre of the site due to failed pumps

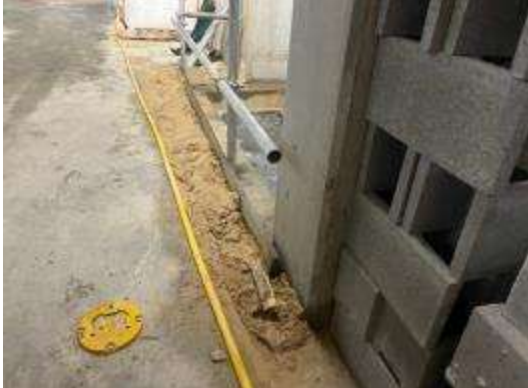
<b>IBCs of Potassium Permanganate stored without secondary containment</b>	<b>Builders sand had been used as a bund to prevent water ingress into open penetrations</b>
<b>Endorsed Document/s</b>	
<ul style="list-style-type: none"> <li>BN OOHWA-005 - Ausgrid Pit Inspection</li> <li>BN OOHWA-002.1 - Station Works, Dec 2021 &amp; Jan 2022</li> </ul>	
<b>Non-compliance/ Incidents or Repeat Complaints</b>	
<p>Sydney Metro has been providing summaries of complaints to DPIE daily and a summary to the ER. Responses to each complaint have been noted in each complaint report, with follow-up actions often defined in revised reports. Key or repeat items of note are discussed below for Barangaroo Station.</p>	
<p>There were no non-compliances reported to the ER for Barangaroo Station for the period.</p>	
<p>There were no incidents for Barangaroo Station reported to the ER under conditions A41 of SSI 7400.</p>

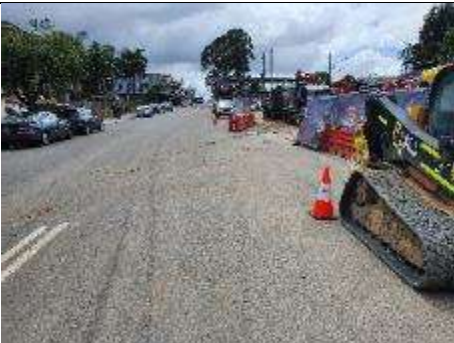
<b>Lakemba – MSB formwork for retaining wall</b>	<b>Lakemba – MSB loadout of spoil (minor tracking actioned)</b>
<b>Endorsed Document/s</b> <ul style="list-style-type: none"> <li>OOH WE17</li> <li>Stormwater and flooding management plan. The plan has been reviewed and will be incorporated into the next Rev of the SWMP.</li> <li>MCL CTR Q1_Q2 2021 (Package 4)</li> </ul>	
<b>Non-compliance/ Incidents or Repeat Complaints</b>	
<p>Sydney Metro has been providing summaries of complaints to DPIE daily and a summary to the ER. Responses to each complaint have been noted in each complaint report, with follow-up actions often defined in revised reports. Key or repeat items of note are discussed below for MCL.</p>	
<p>The ER is aware of one NCR for the month and two complaints relating to MCL works and two not related to MCL works for the period.</p>

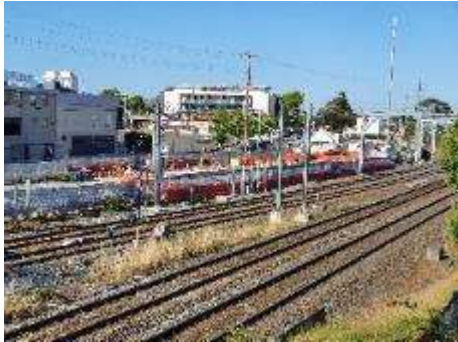
<b>Campsie MSB</b>	<b>Dulwich Hill MSB and Abutment A</b>
<b>Endorsed Document/s</b>	
<ul style="list-style-type: none"> <li>Soil and Water Management Plan for DCP and HBW (Endorsed 15/11/21)</li> <li>Heritage Management Plan for DCP and HBW (Endorsed 15/11/21)</li> <li>OOH Emergency works</li> <li>OOH WE19</li> <li>HBW Compliance Tracking Review (CTR) Q1_Q2 2021 (package 5)</li> <li>DCP CTR Q1_Q2 2021 (package 6)</li> <li>A19 Minor Ancillary Facility Assessment HP MSB</li> </ul>	
<b>Non-compliance/ Incidents or Repeat Complaints</b>	
<p>Sydney Metro has been providing summaries of complaints to DPIE daily and a summary to the ER. Responses to each complaint have been noted in each complaint report, with follow-up actions often defined in revised reports. Key or repeat items of note are discussed below for HBW.</p>	
<p>The ER is aware of one new non-compliance raised in November for October activities, and twelve complaints for DCP/HBW for the period (noting that three were not related to Downer's works).  The NCR was in relation to the installation of banner mesh at Wiley park in accordance with CoA A20.</p> <p><u>Complaints:</u>  All complaints are summarised as follows:</p> <p><u>Hurlstone Park</u></p> <ul style="list-style-type: none"> <li>One complaint for general noise during construction, investigation indicated Sydney Trains were tamping during this period (Not related to Downer).</li> <li>One complaint regarding the relocation of the bus stop and parking fines (related to council activities and not Downer works)</li> </ul> <p><u>Wiley Park</u></p> <ul style="list-style-type: none"> <li>Three complaints relating to traffic and parking</li> </ul> <p><u>Dulwich Hill</u></p> <ul style="list-style-type: none"> <li>One dust complaint</li> <li>One property access complaint</li> <li>Two noise complaints (one for site radio and one general)</li> <li>One water management (noted to be during significant rainfall event that overflowed controls)</li> </ul> <p><u>Punchbowl</u></p> <ul style="list-style-type: none"> <li>One related to noise and expected timeframe of works (mis-read notification and noise works not related to Downer)</li> </ul> <p>There were no incidents for HBW or DCP reported to the ER under conditions A36 of SSI 8256.</p>
