7 April 2025 Ref:201209-ER\_DPHI-March 2025

# RE: Sydney Metro - Sydney Metro Western Sydney Airport SSI 10051 – ER Monthly Report for March 2025

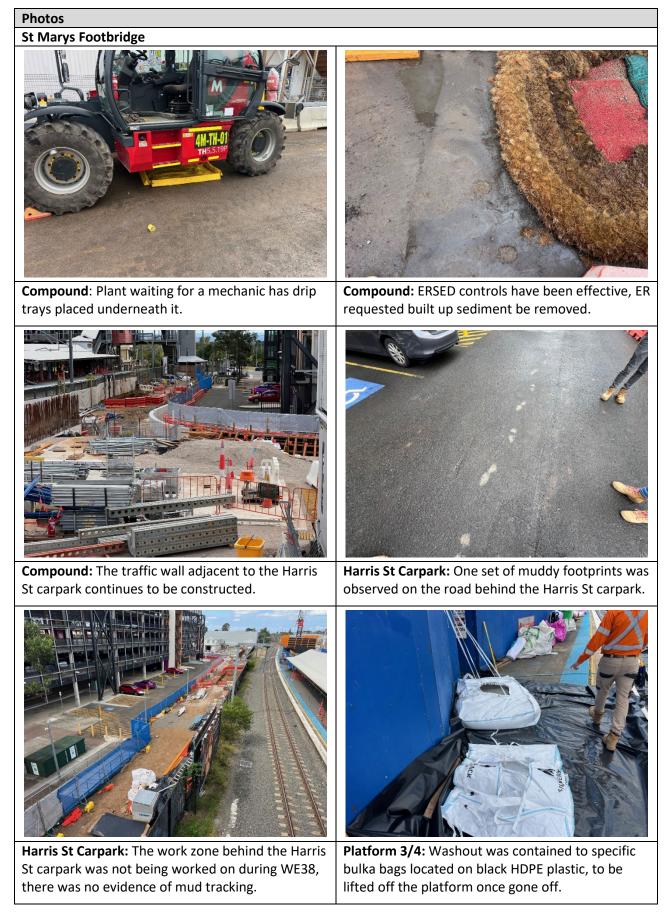
<ul> <li>The main works during WE38 Of</li> <li>The compound was largely tidy,</li> <li>A set of muddy footprints was o exit points with boot cleaning face</li> </ul>	bserved again on t cilities have been i	ks being undertaken he road behind the Harris St carpark. Dedicated			
<ul> <li>The main works during WE38 Of</li> <li>The compound was largely tidy,</li> <li>A set of muddy footprints was o exit points with boot cleaning fa</li> <li>Stabilised access point and balla prove to be ineffective</li> </ul>	bserved again on t cilities have been st layers need to b	ks being undertaken he road behind the Harris St carpark. Dedicated recommended.
