Planning Approval Consistency Assessment Form

Assessment Name:	Samuel Marsden Road Sewer main – revised underbore alignment and tree removal
Prepared by:	Parklife Metro (PLM)
Prepared for:	Stations, Systems, Trains, Operations and Maintenance (SSTOM) contractors
Assessment number:	PLM CA001
Type of assessment:	Assessment under EP&A Act 1979, Division 5.2
Version:	Draft (Rev 1.0)
Planning approval No. (where relevant):	e.g. SSI 10051
Date required:	February 2026
iCentral number	SM-26-00013605

Samuel Marsden Road Sewer Main, Orchard Hills Aboriginal Due Diligence Assessment

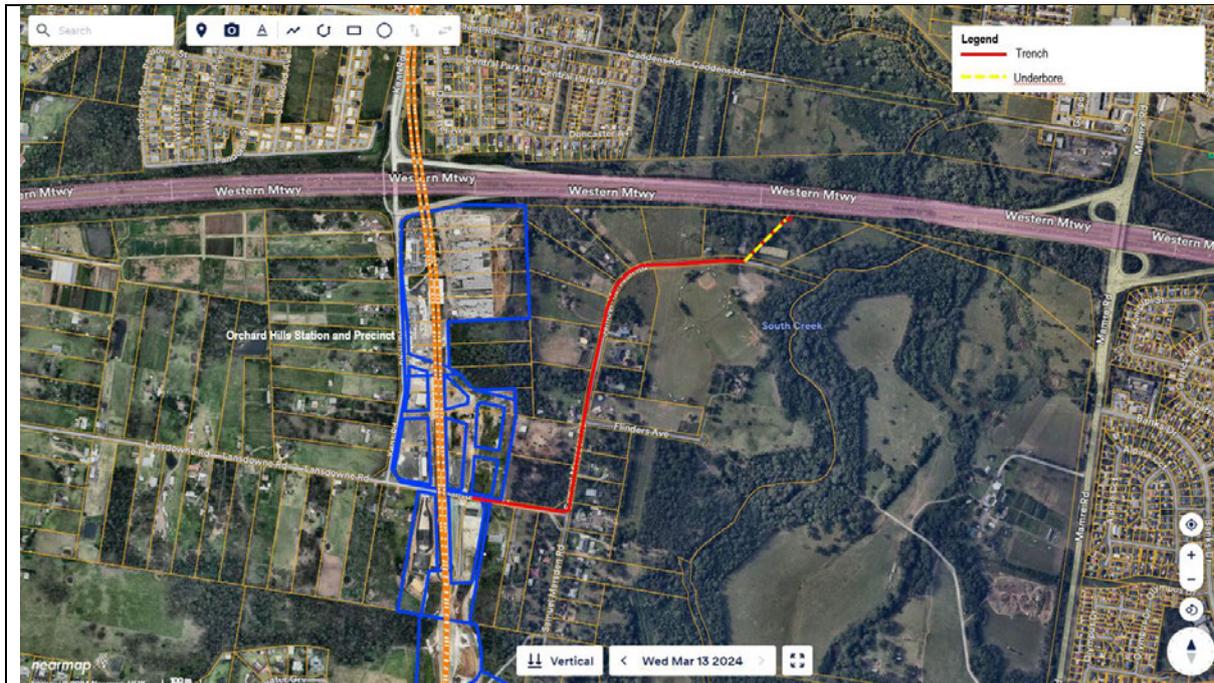
Figure A1 Location of works area and construction method (As approved under SSTOM ER003 Environmental Review - Orchard Hills Station Sewer Main Lansdowne and Samuel Marsden Roads (dated 29 April 2024)).

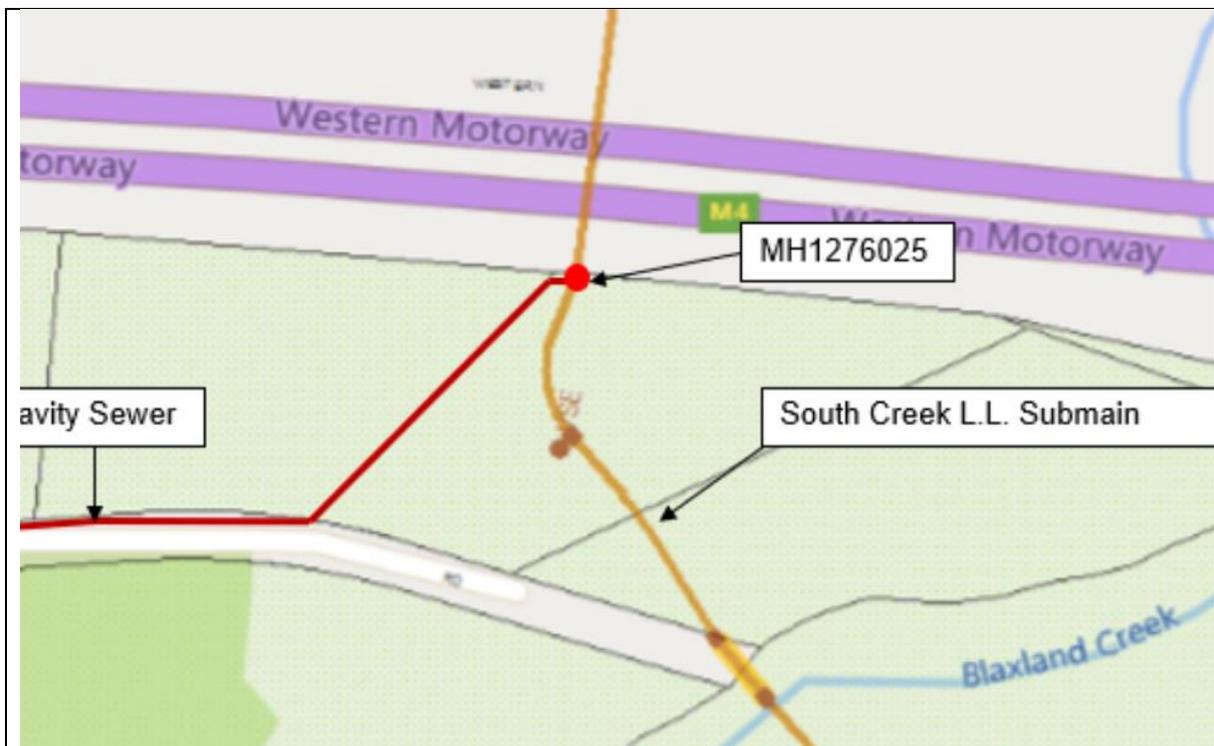
Figure A2 Connection to existing Sydney Water sewer submain. (As approved under SSTOM ER003 Environmental Review - Orchard Hills Station Sewer Main Lansdowne and Samuel Marsden Roads (dated 29 April 2024))

- A design option was proposed to connect the new sewer main directly to the Sydney Water sub-main. This option involved adjusting the connecting directly to the existing 1350mm sewer sub-main by constructing the maintenance hole directly over the sub-main. This option was found to present significant complexity for both design and construction. Direct connection to the active sewer main would require a detailed flow management strategy to initially inform design and then a high level of flow management during construction in comparison to a breakthrough connection to an existing maintenance hole. In addition, the size of the existing carrier main would require a custom maintenance hole design, requiring specialist engineering input and multiple non-standard review stages with Sydney Water. The WSC has advised this options would be unacceptable to Sydney Water and progressing this options would also create a risk to the construction program. This option has been discounted. The location of the maintenance hole has been retained. Tree removal at MH19 is required.

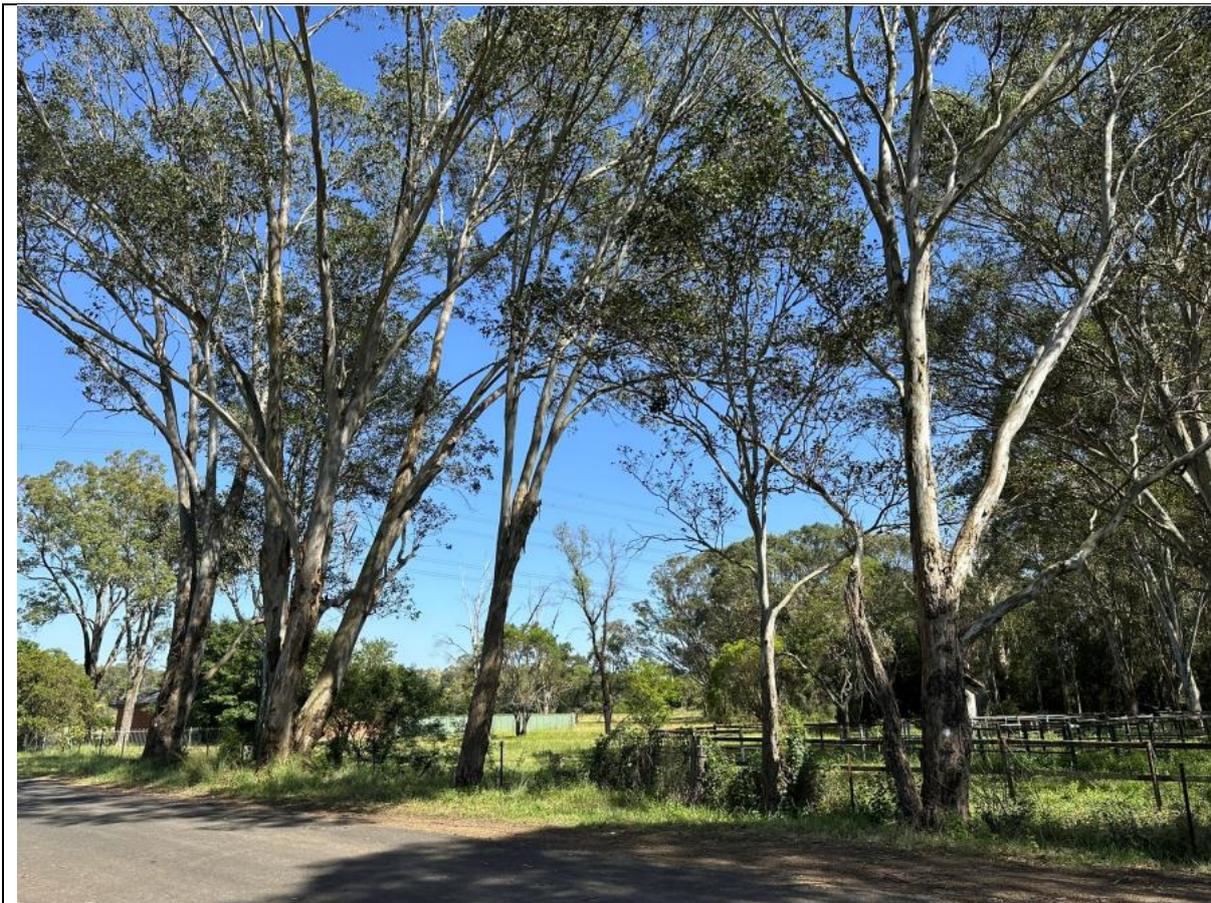
Figure A4 Samuel Marsden Road – Cabbage Gums (vegetation avoided my maintenance hole / underbore entry pit relocation)

The deletion of the final maintenance hole on Samuel Marsden Road removes any risk of damage or removal of the stand of trees along the northern verge of Samuel Marsden Road. This change also reduces material use and avoids construction of unnecessary infrastructure.

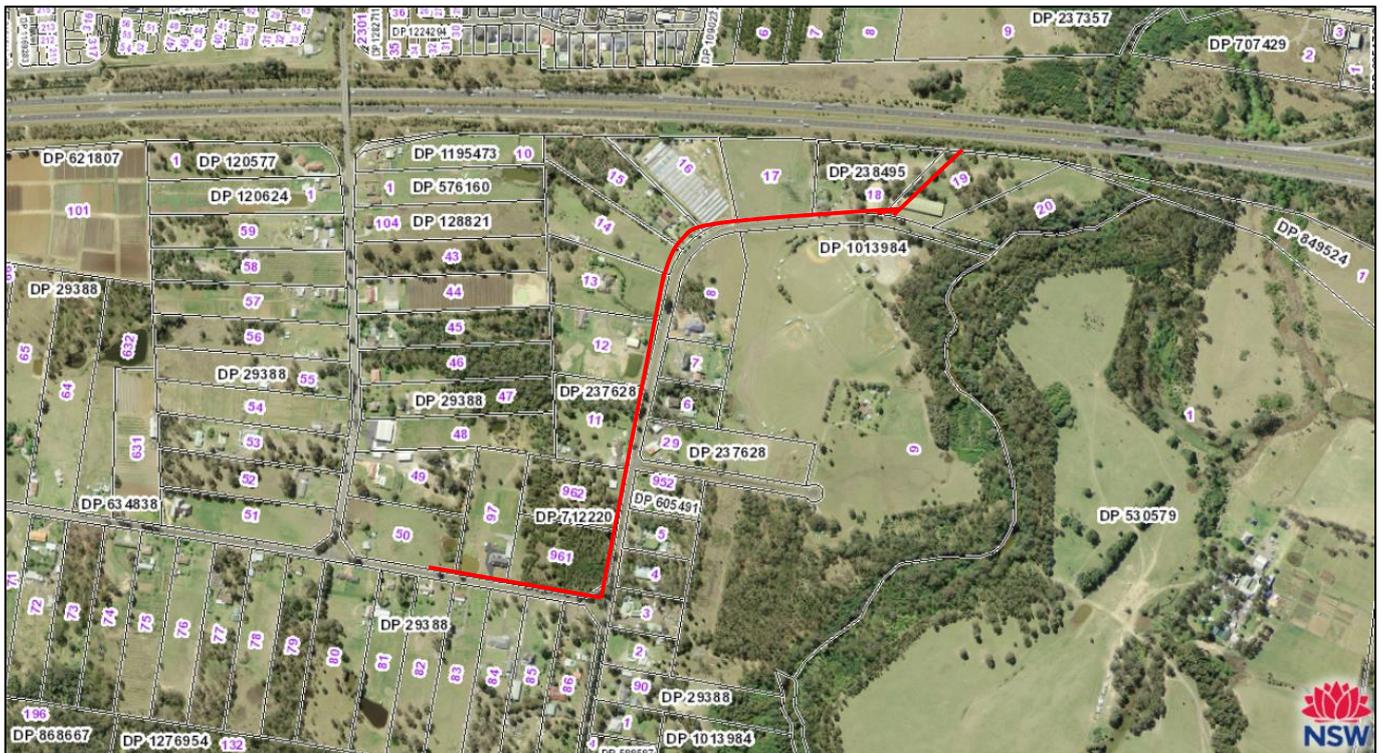
Figure 3: Showing the approximate proposed route of the sewer main indicated by the red line on the aerial photograph (aerial courtesy of Six Maps).

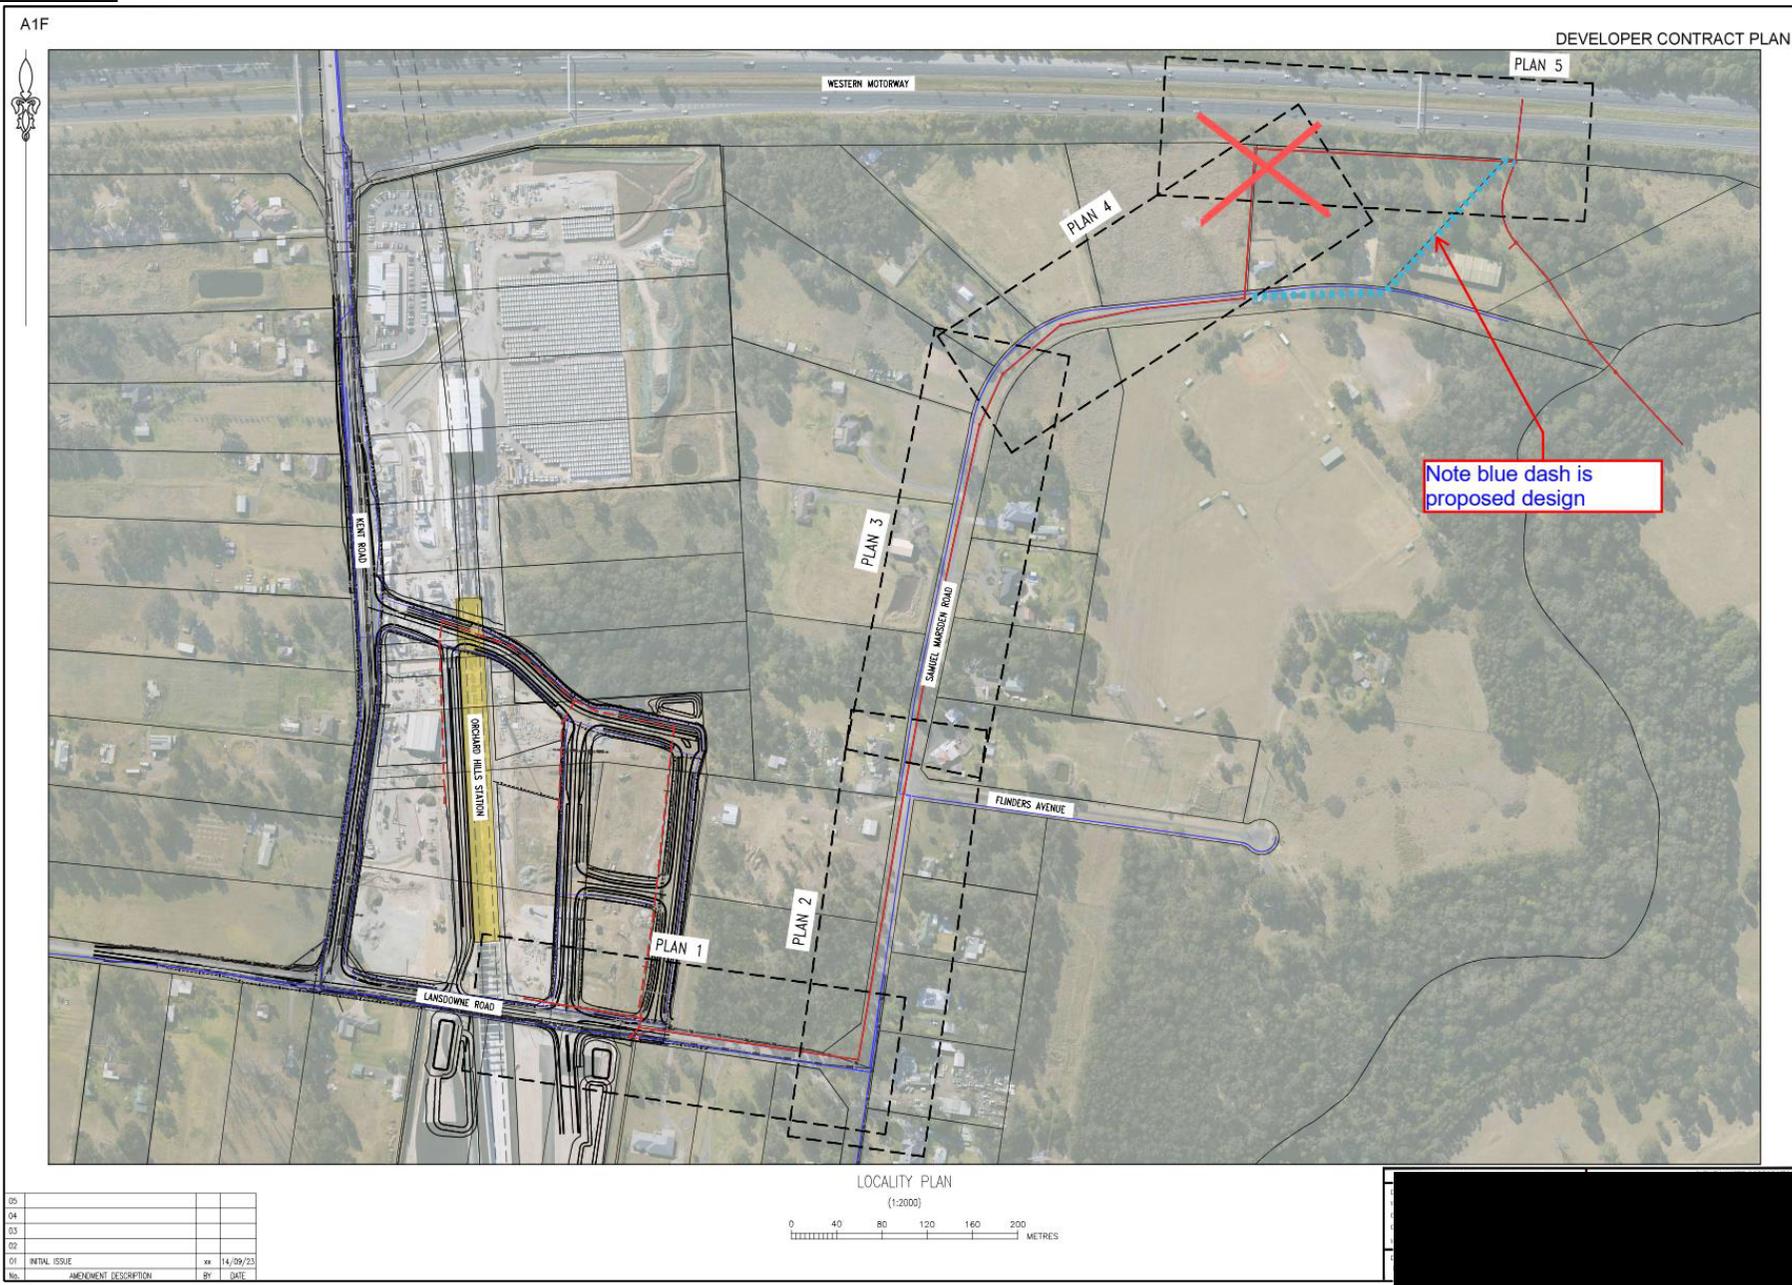
Figure 4: Showing the proposed route of the gravity sewer main indicated by the solid red line and the dashed blue line.

The proposed works include the construction of a new approximately 1400m long sewer main predominantly in the road verge. Proposed construction is via open trenching and underboring where required, e.g. where space in the road verge is limited. Maintenance holes are proposed along the route with a maximum interval of approximately 250m.

Figure 4 below shows the proposed route of the sewer main.

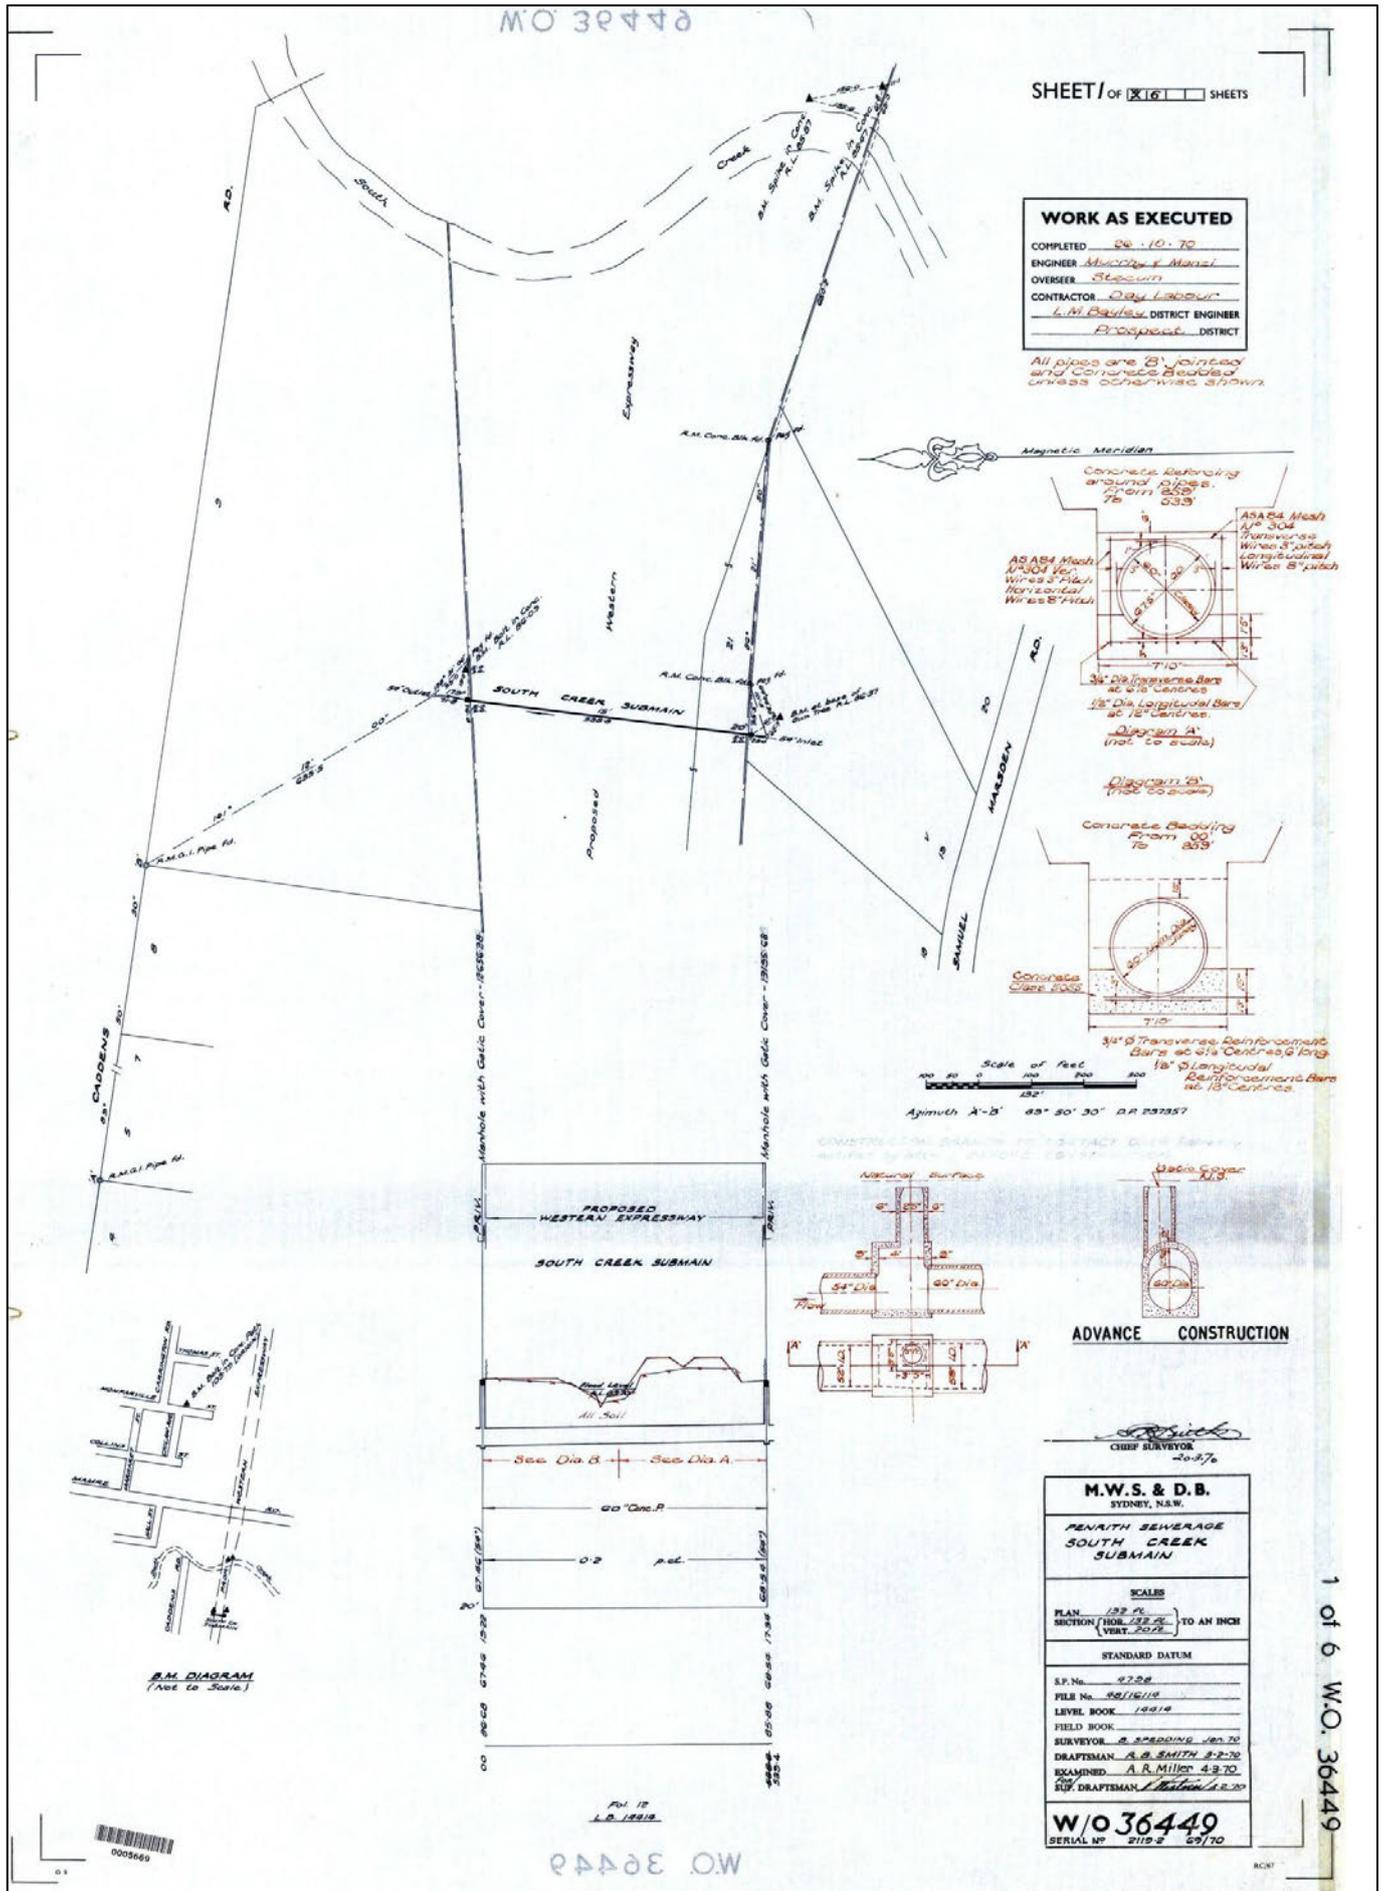
Figure 7: Sydney Water plan dated 1970 showing Lot 19 DP238495 outlined in red and showing the extensive infrastructure through Lot 19 DP238495 (plan courtesy of Sydney Water).

Sydney Water plans from 1970 (Figure 7) and 1971 (Figure 8 and Figure 9) show extensive Sydney Water infrastructure being constructed through Lot 19 DP238495 at this time. The plans show Sydney Water constructed pipes throughout the study area. The 1975 and 1986 aerial photographs show the study area remaining undeveloped and the Western Motorway being formed. There is no evidence to indicate that any structures have previously been built within the property at the end of Samuel Marsden Road where the sewer main will connect into the existing Sydney Water DN1350 submain, prior to the construction of the existing farm building which appears to have been constructed between 1991 and 1998. Sydney Water plans from 1991 (Figure 10) appear to show similar infrastructure to that shown in the 1971 plans.

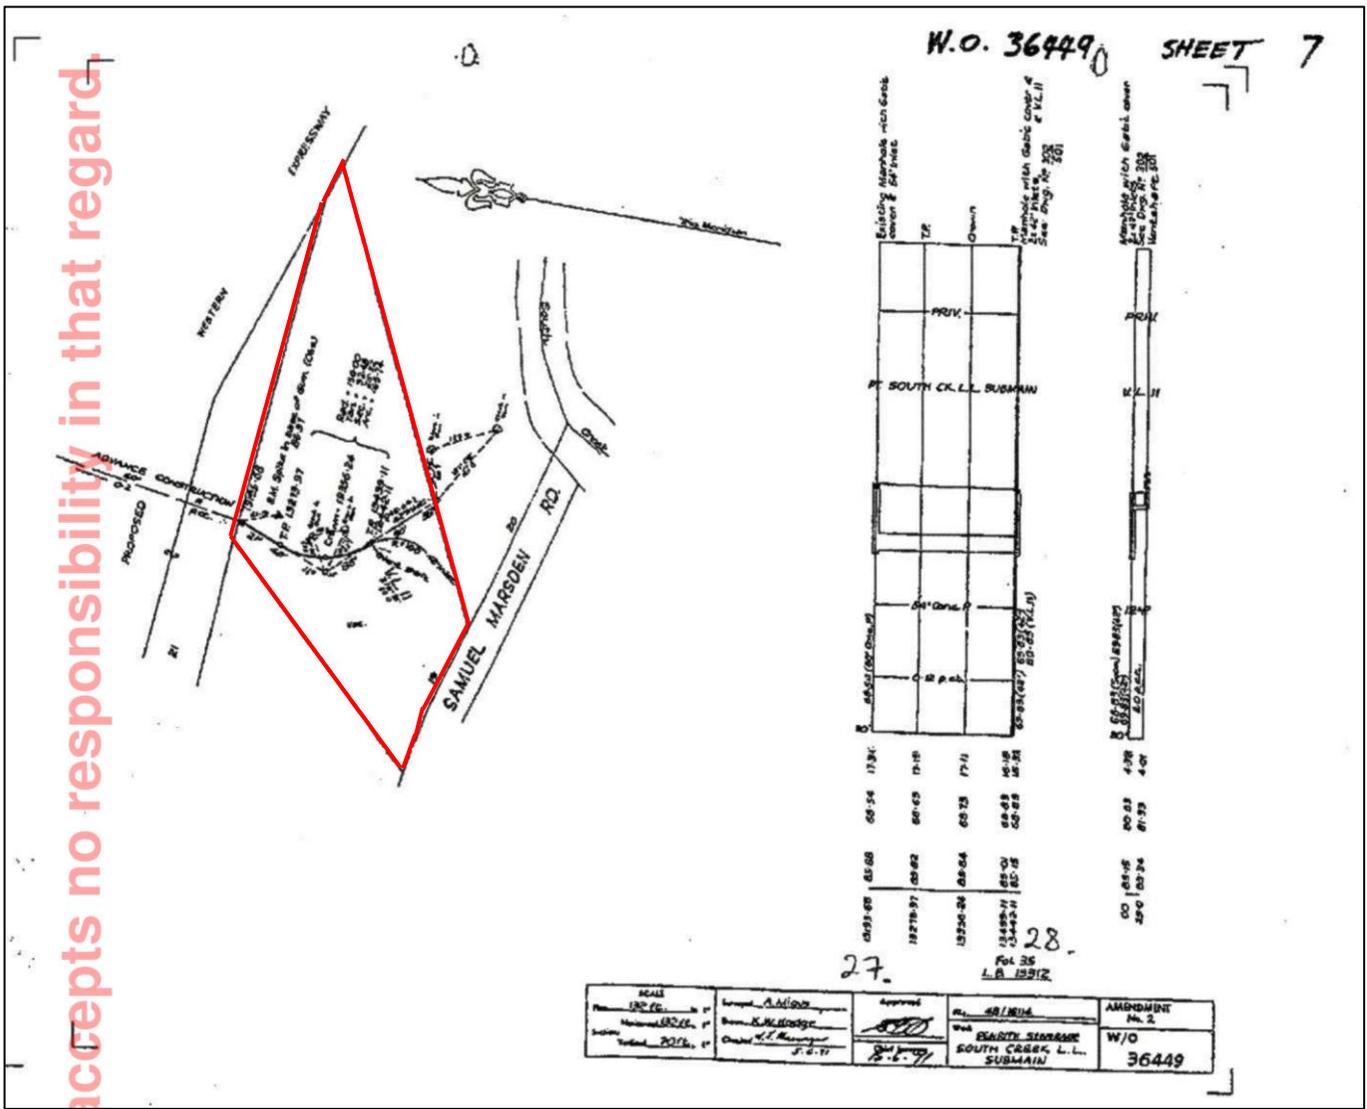
Figure 10: Showing the Sydney Water plans from 1991. Lot 19 DP238495 is outlined in red and the Sydney Water Infrastructure through the Lot 19 DP238495 is extensive (plans courtesy of Sydney Water).

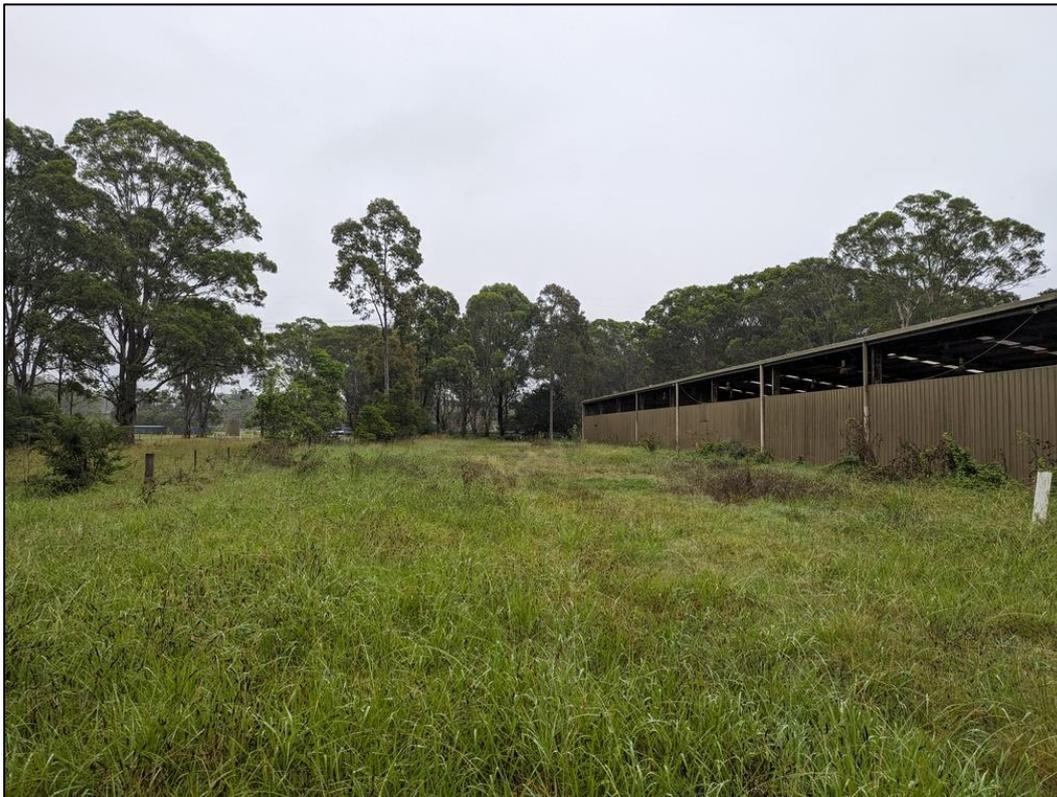
Photograph 1: Showing the property at the end of Samuel Marsden Road where the proposed sewer main will connect to the existing Sydney Water DN1350 submain. The existing farm building is visible on the right of the photo.

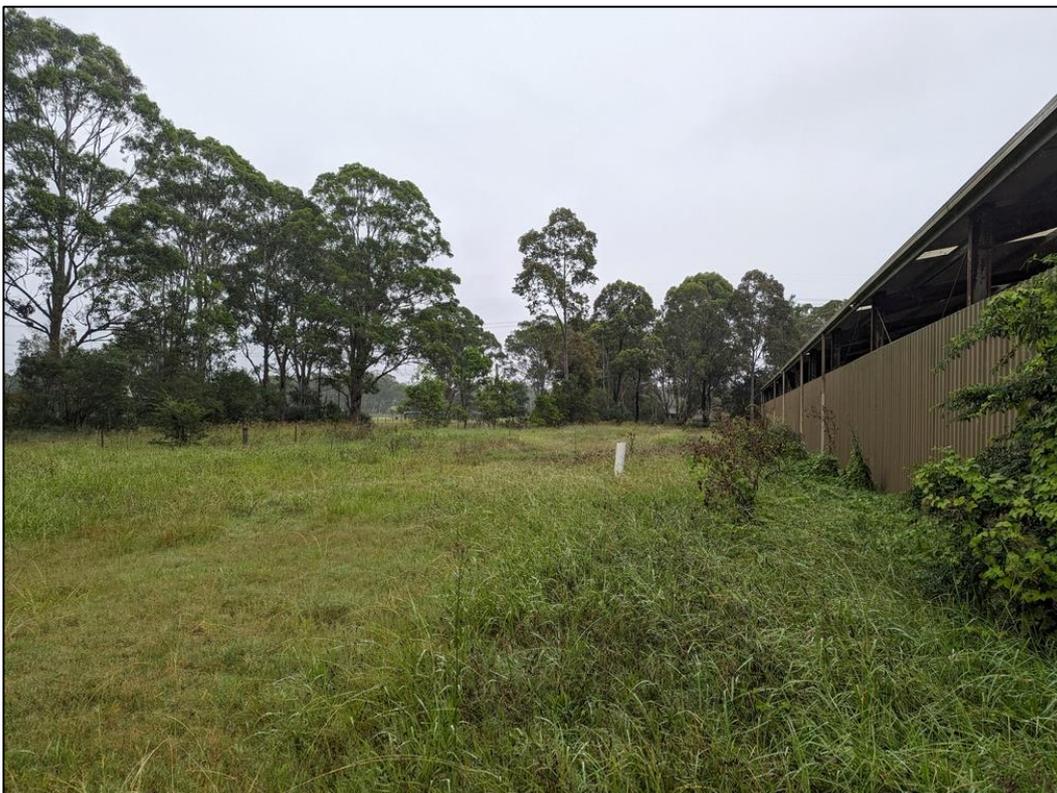
Photograph 2: Showing the area to the north of the existing farm building where a small waterhole was present in the 1965 aerial photograph.

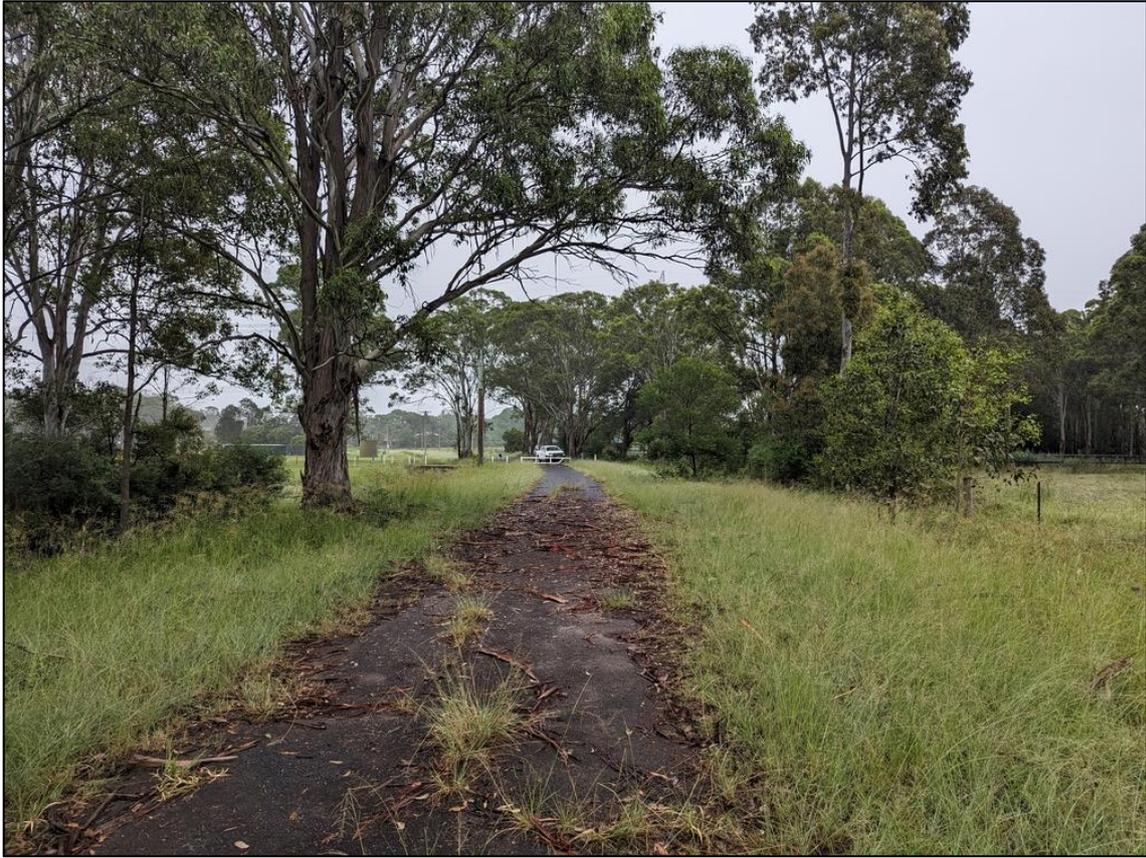
Photograph 5: Facing west and looking along Samuel Marsden Road. The proposed sewer main will be constructed in the road reserve to the right of the photo.

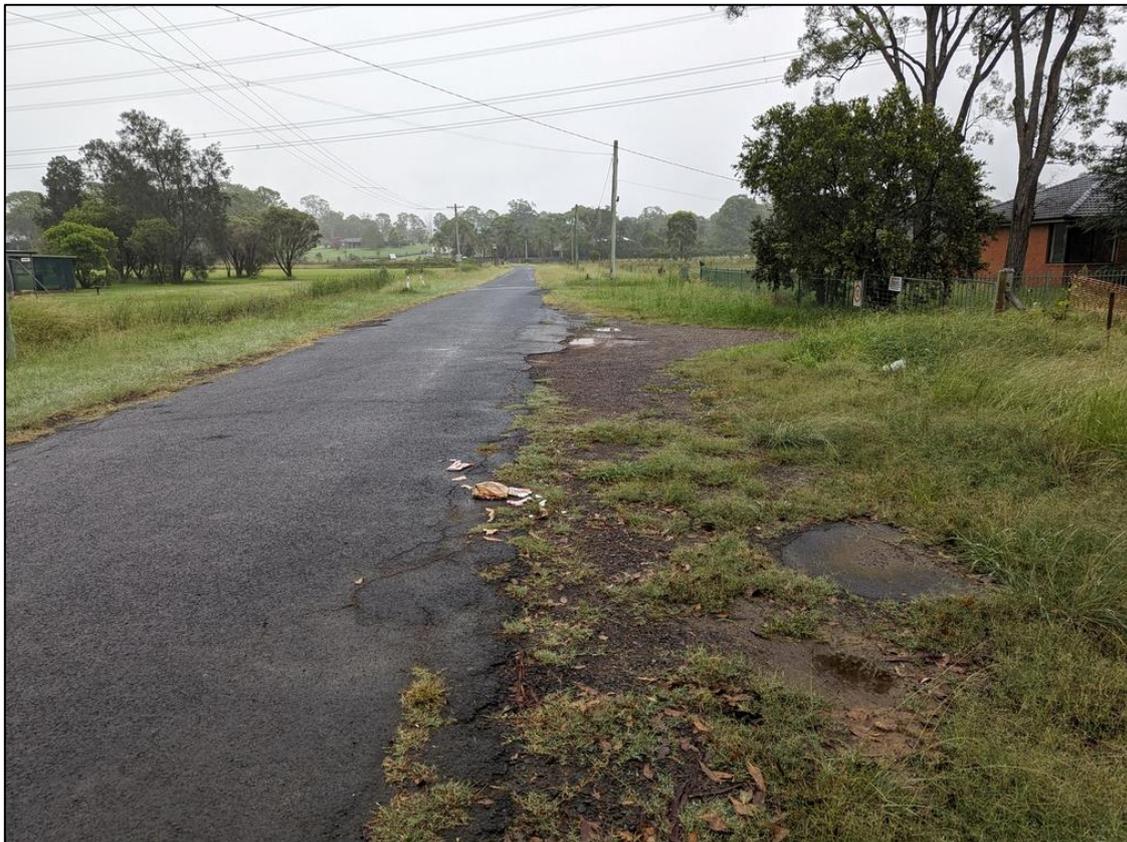
Photograph 6: Facing west and looking along the road reserve of Samuel Marsden Road where the proposed sewer main will be constructed.

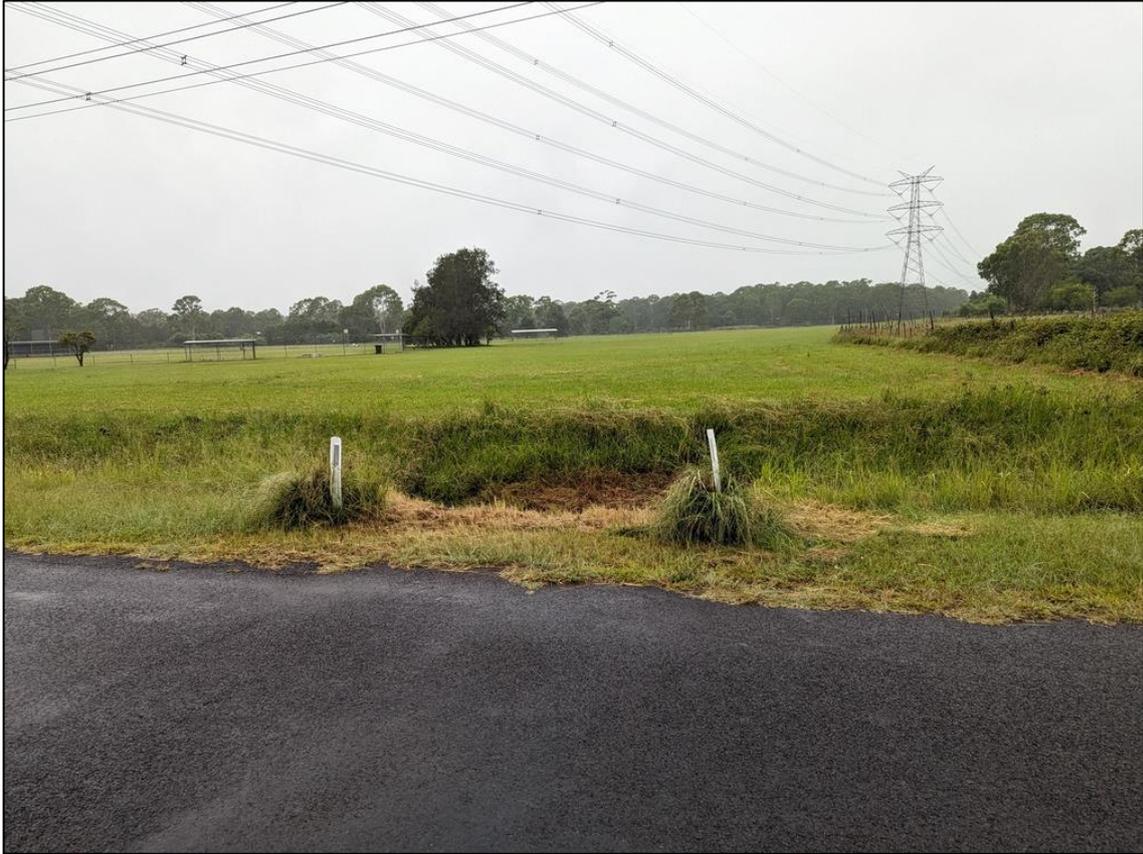
Photograph 7: Showing evidence of drainage channels within the road reserve.

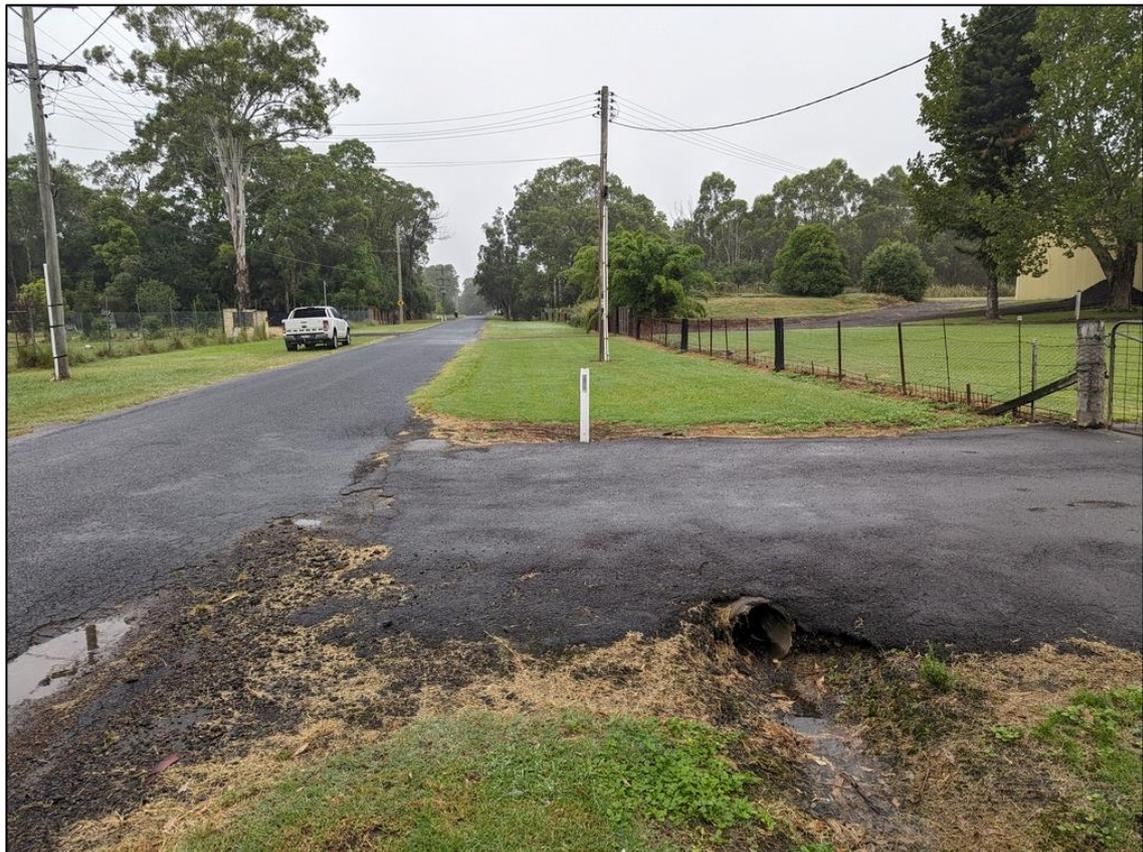
Photograph 8: Showing evidence of drainage pipes installed beneath driveways along Samuel Marsden Road.

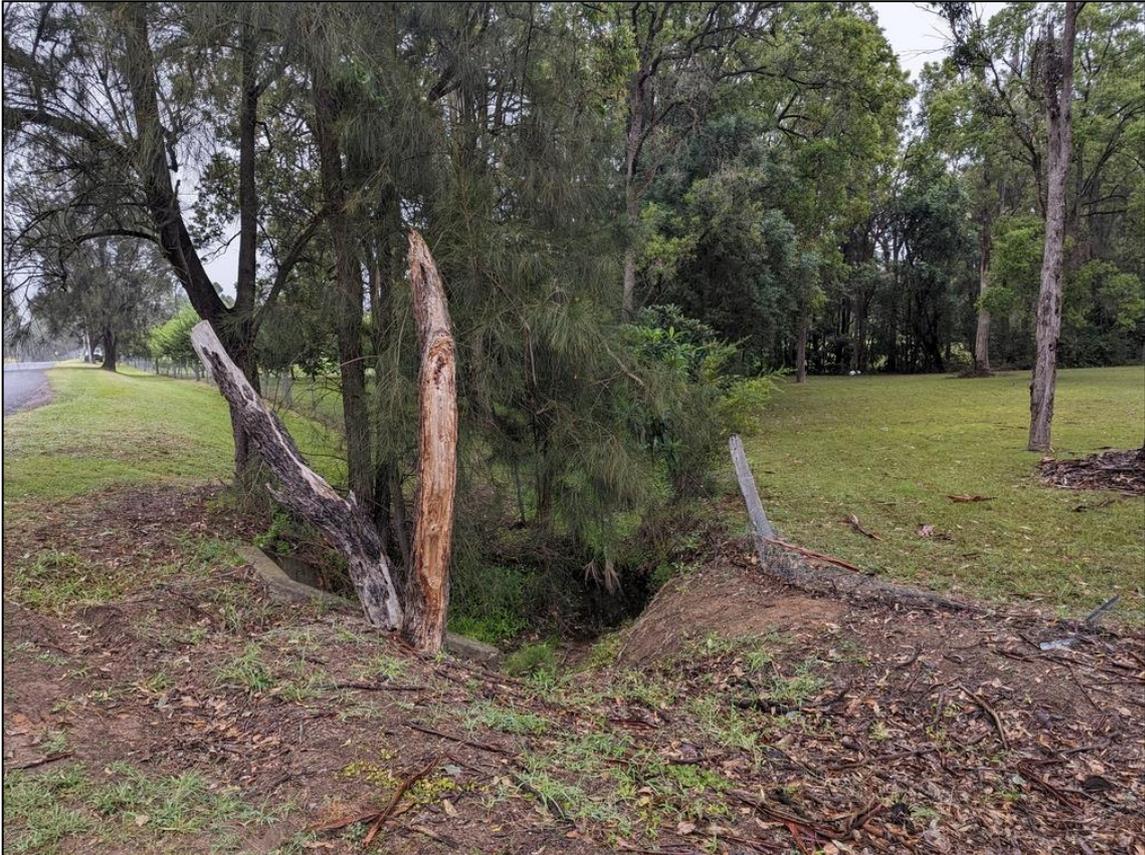
Photograph 9: Showing evidence of a creek within the road reserve of Samuel Marsden Road.

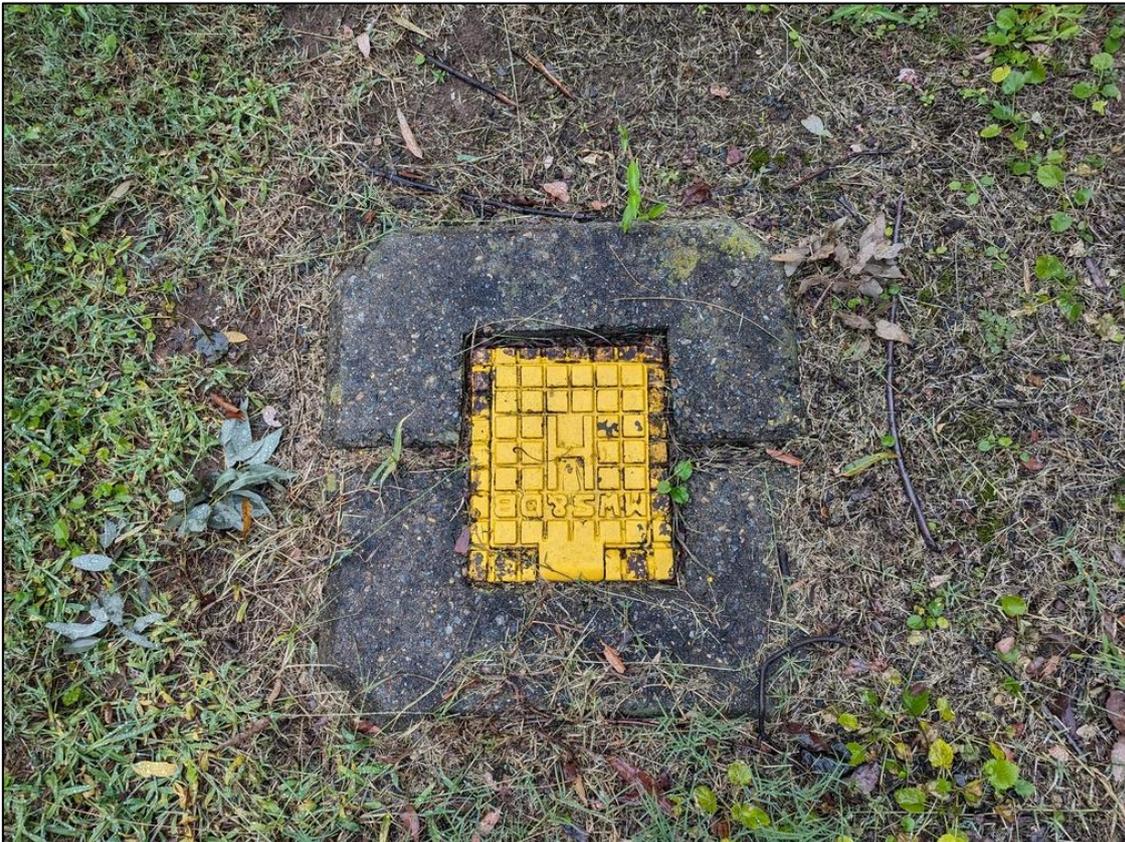
Photograph 10: Showing evidence of underground services within the road reserve of Lansdowne Road.

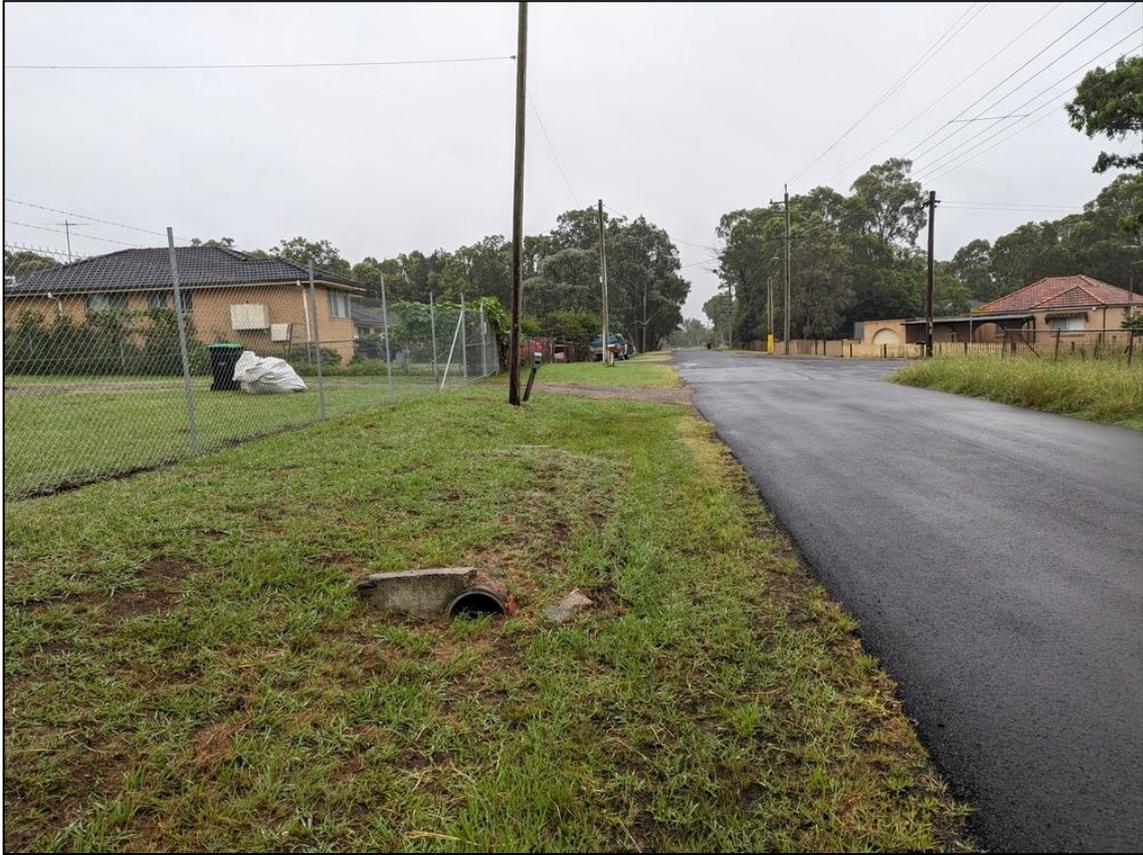
Photograph 11: Showing evidence of drainage channels within the road reserve.

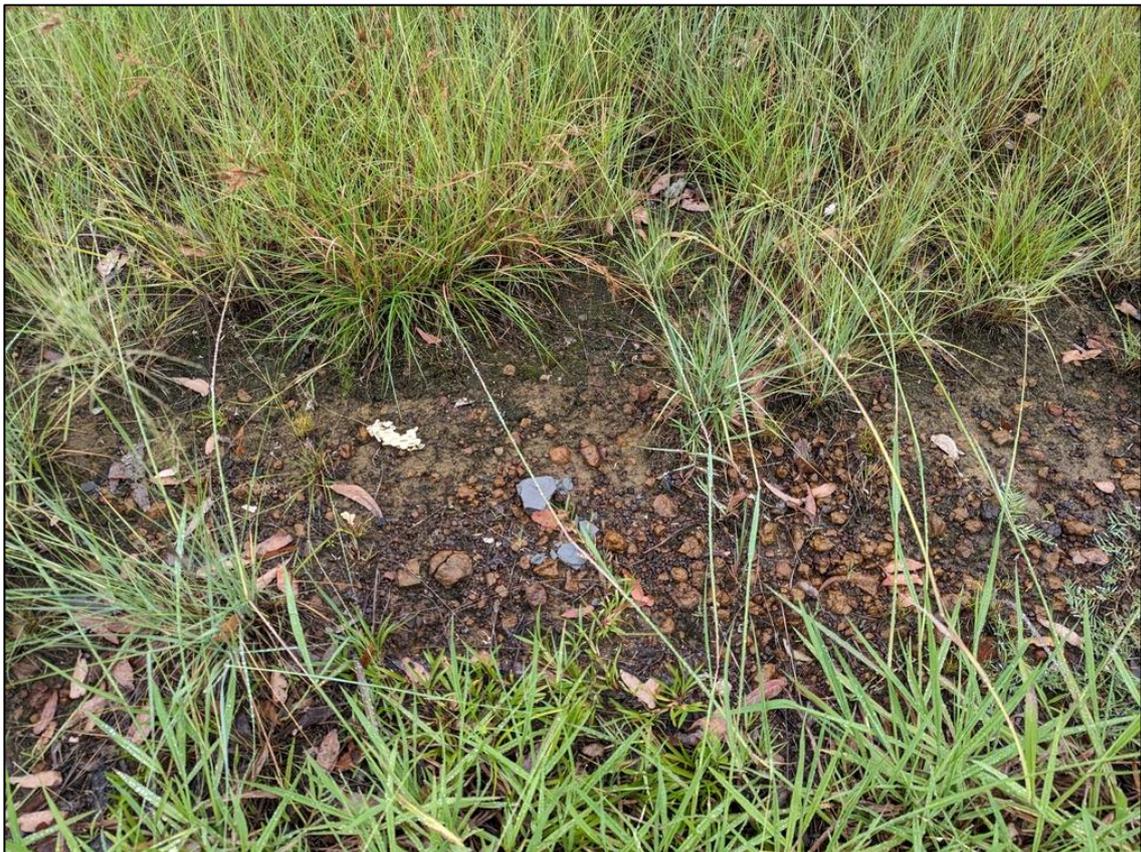
Photograph 12: Showing the imported gravels and disturbance of the Lansdowne Road road reserve.
