Planning Approval Consistency Assessment Form

Assessment Name:	Samuel Marsden Road Sewer main – revised underbore alignment and tree removal
Prepared by:	Parklife Metro (PLM)
Prepared for:	Stations, Systems, Trains, Operations and Maintenance (SSTOM) contractors
Assessment number:	PLM CA001
Type of assessment:	Assessment under EP&A Act 1979, Division 5.2
Version:	Draft (Rev 1.0)
Planning approval No. (where relevant):	e.g. SSI 10051
Date required:	February 2026
iCentral number	SM-26-00013605

Samuel Marsden Road Sewer Main, Orchard Hills Aboriginal Due Diligence Assessment

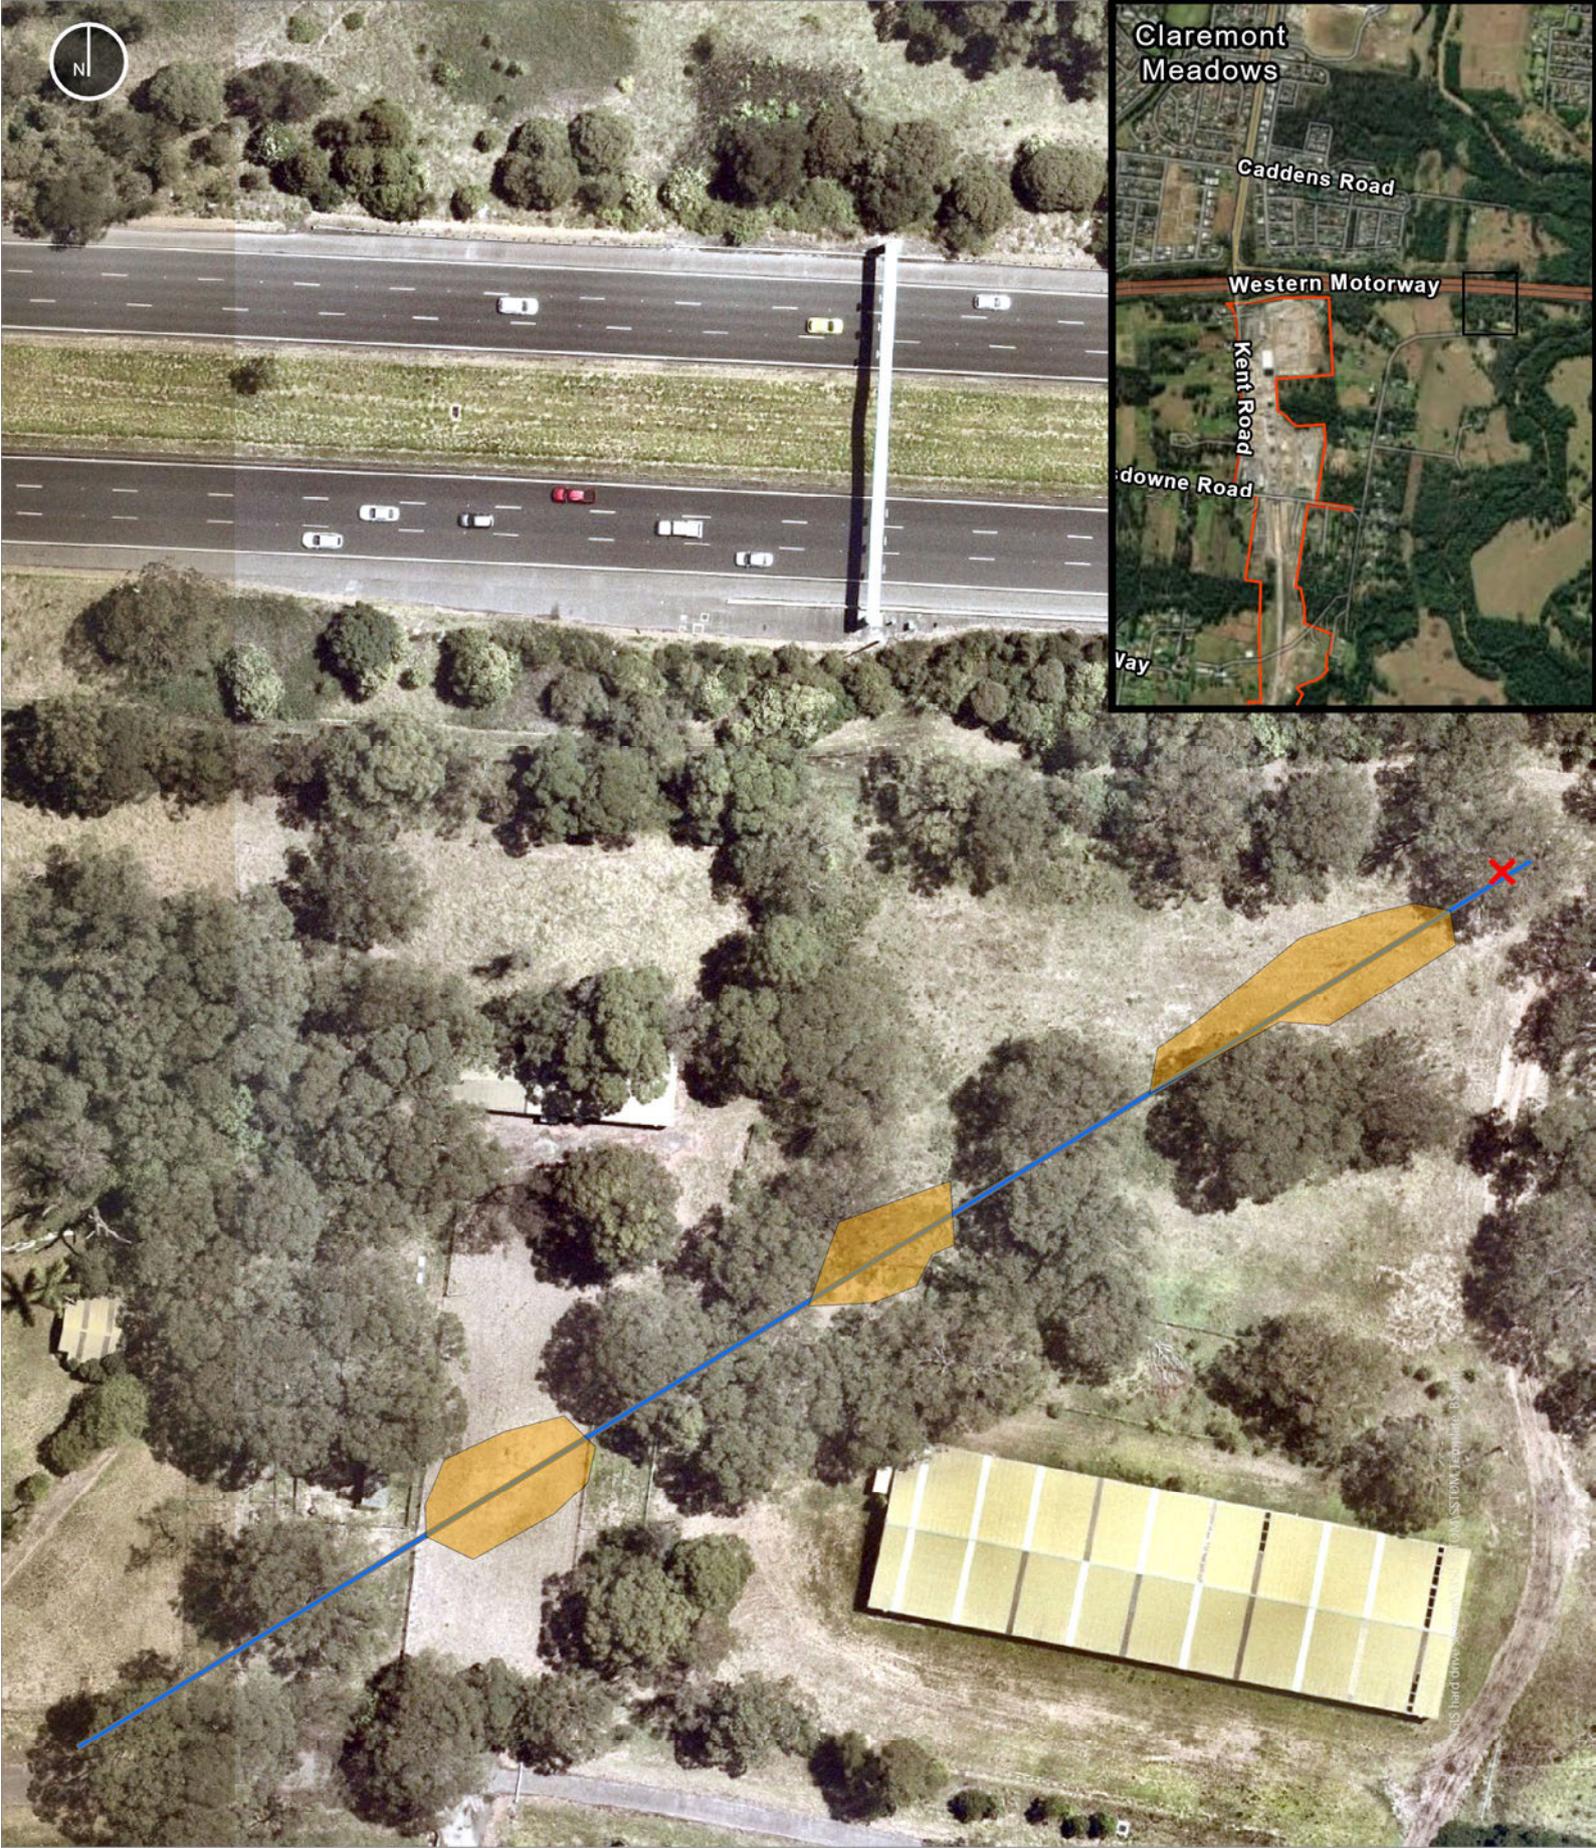
Figure 1 | Samuel Marsden Road Trees to be Removed

WolfPeak ecologist [REDACTED] undertook an onsite pre-clearing inspection on 18th December 2025 for areas marked for tree removal at Samuel Marsden Road (see Figure 1). The two trees are both represented by the single X symbol in the figure, given their immediate proximity to each other. The site inspection consisted of walking transects around the marked trees for removal, recording vegetation and fauna habitat types, and searches for threatened plants and threatened fauna. Details of the trees within the study areas were recorded and inspected for hollows and other fauna habitat features.

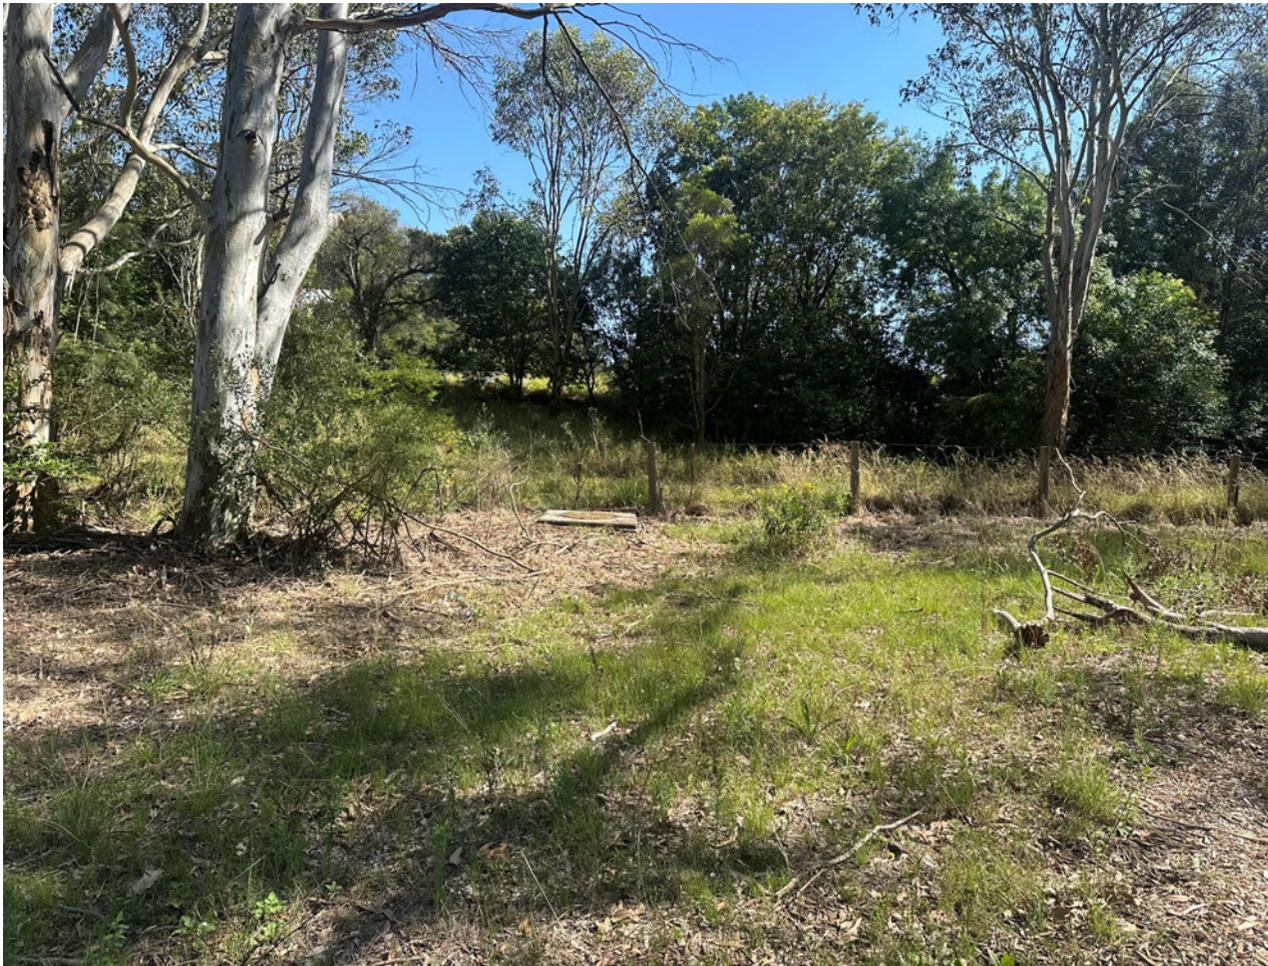
Photo 1: Samuel Marsden Road. Site where tunnel development will emerge. North end of development, proximate to M4.

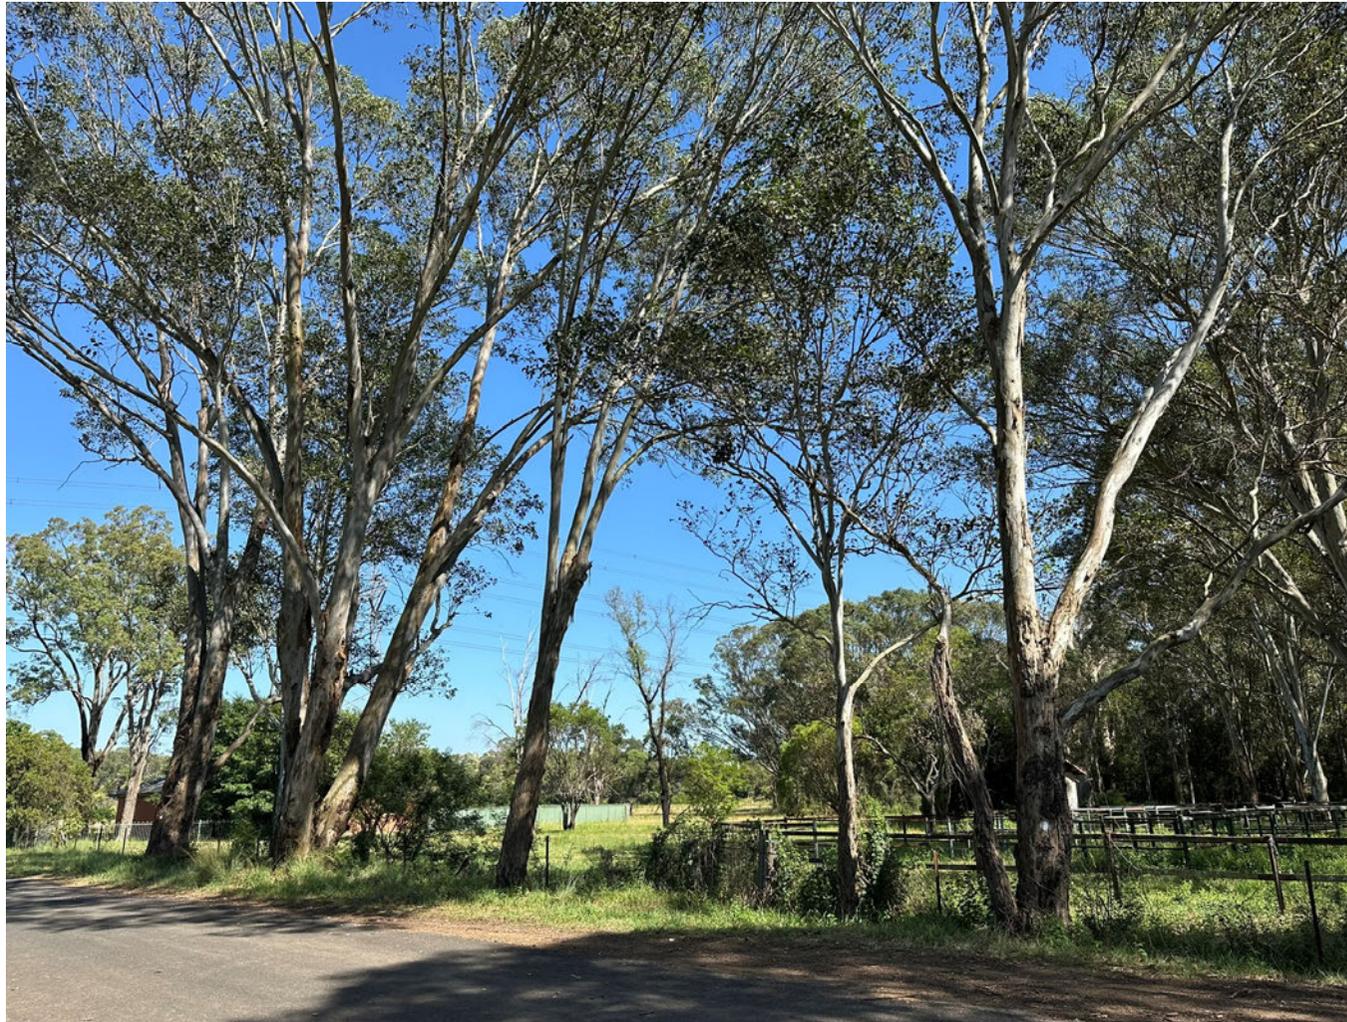
Photo 2: Samuel Marsden Road. Six Cabbage gums which will be retained due to revised design plans by SSTOM.

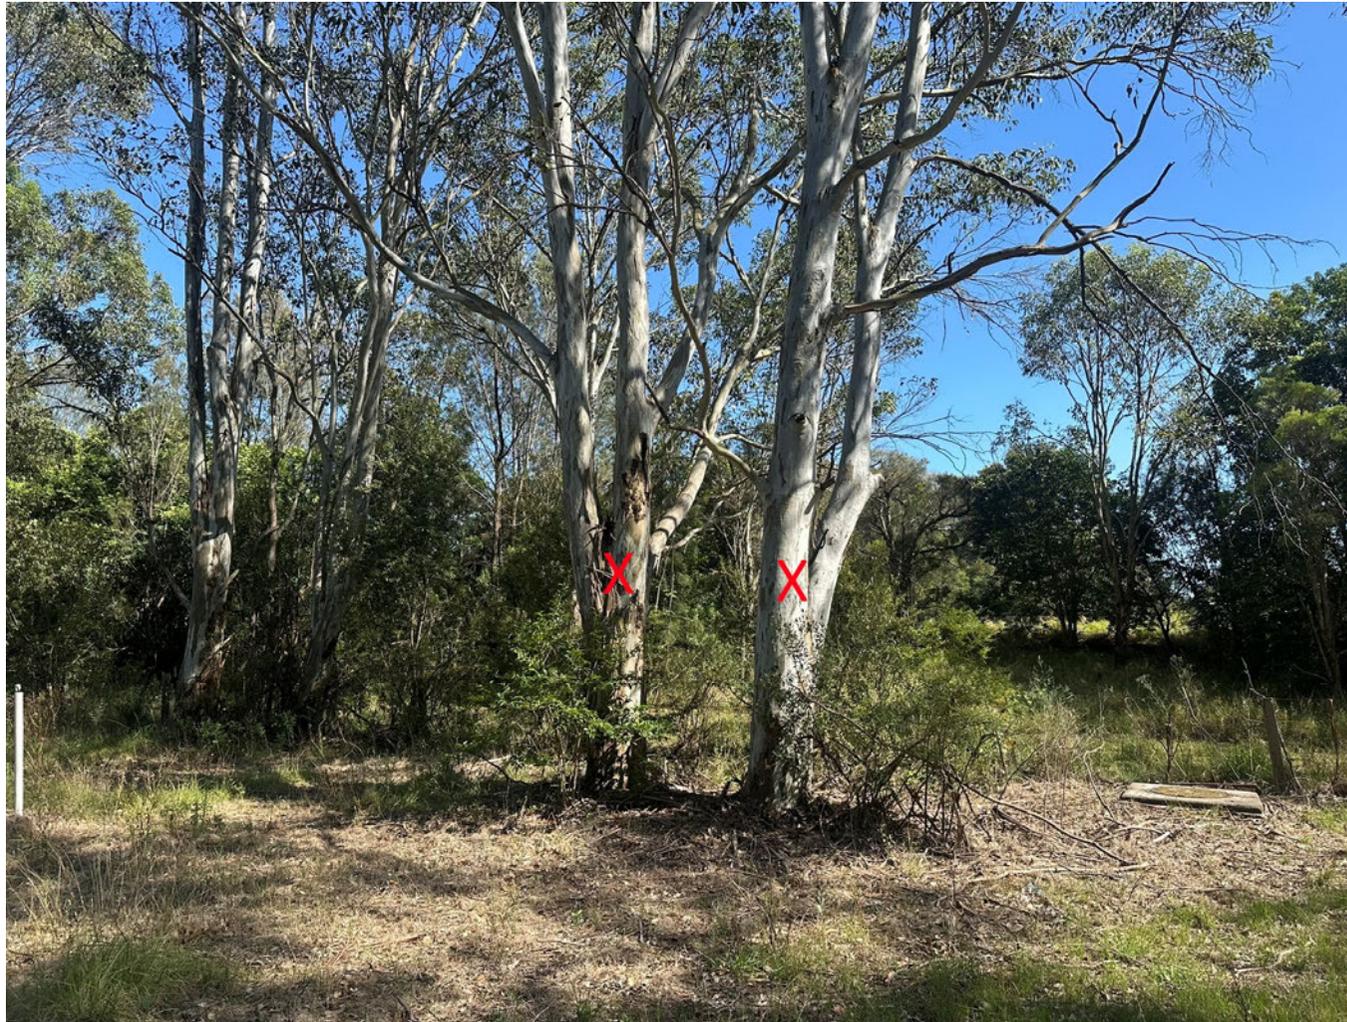
Photo 3: Samuel Marsden Road. Two Cabbage gums marked for removal.
